Damage Mechanisms Affecting Fixed Equipment in the Refining Industry

RECOMMENDED PRACTICE 571
FIRST EDITION, DECEMBER 2003

Downstream Segment

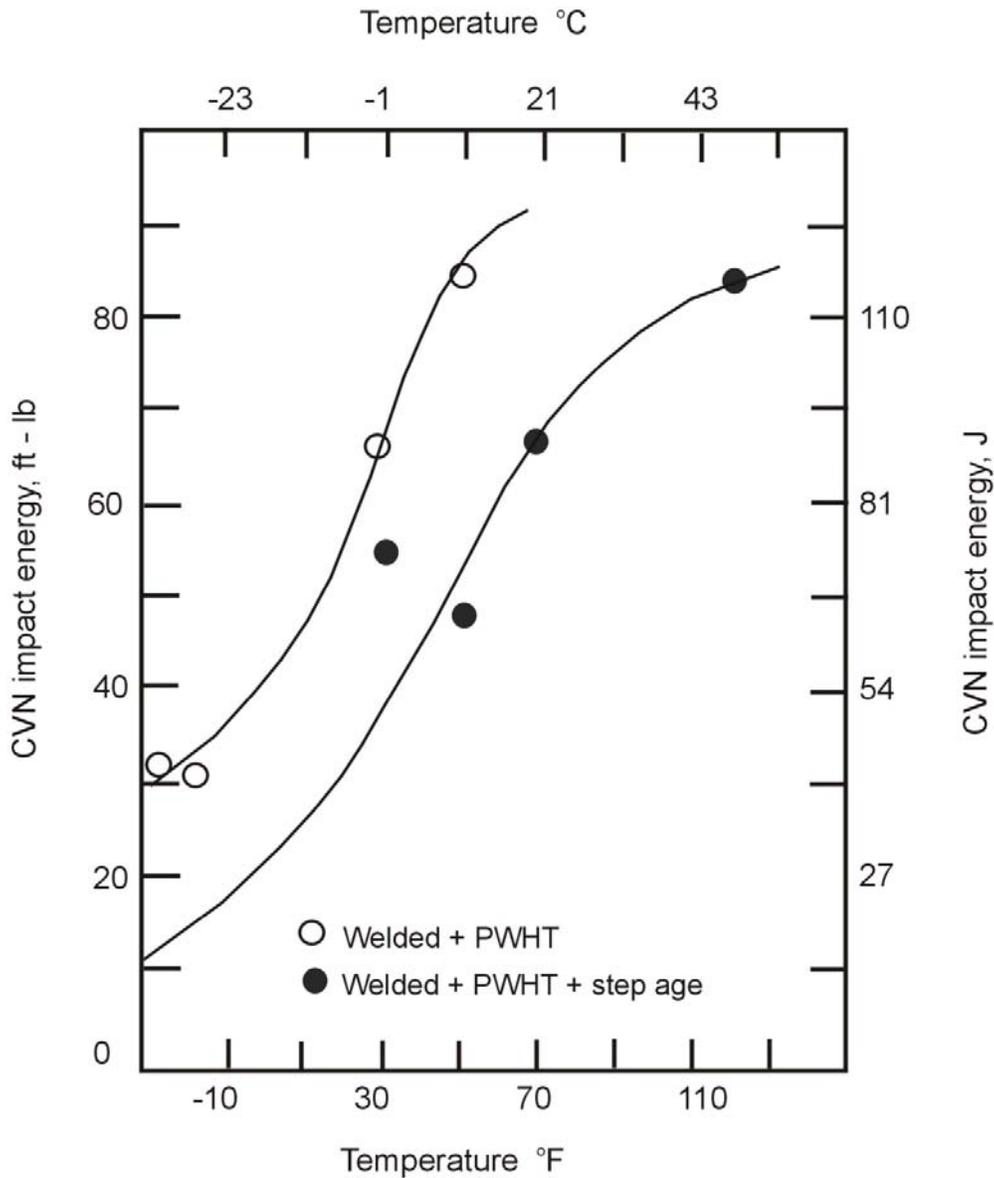
Figure 4-5 – Plot of CVN toughness as a function of temperature showing a shift in the 40-ft-lb transition temperature.

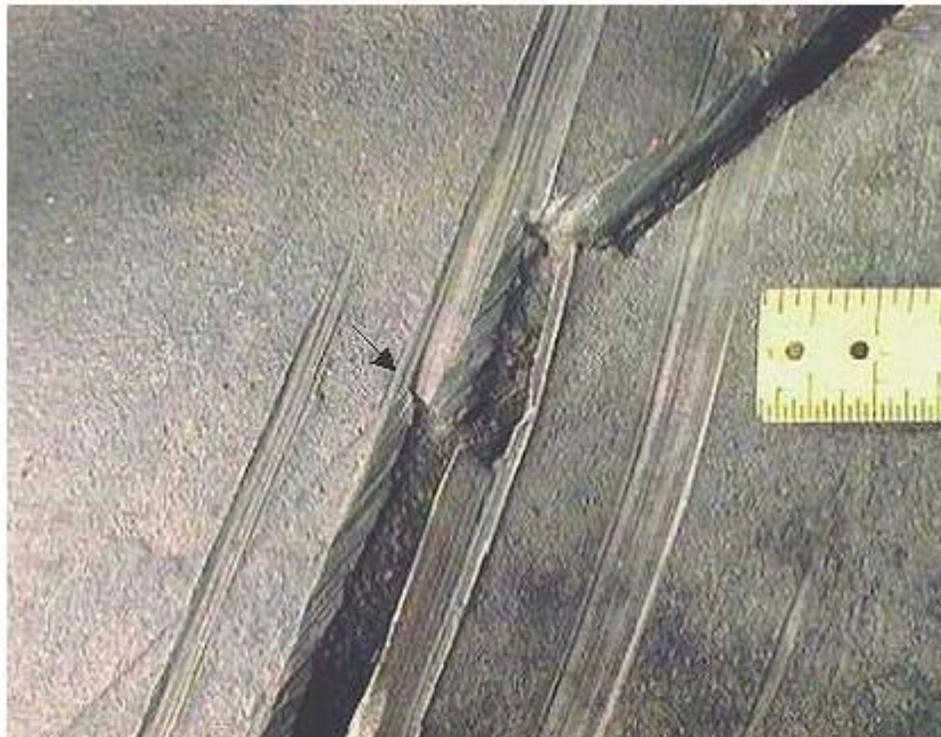
Figure 4-7 – Close-up photograph showing the gouges and the fracture origin (arrow) in one of the gouges.

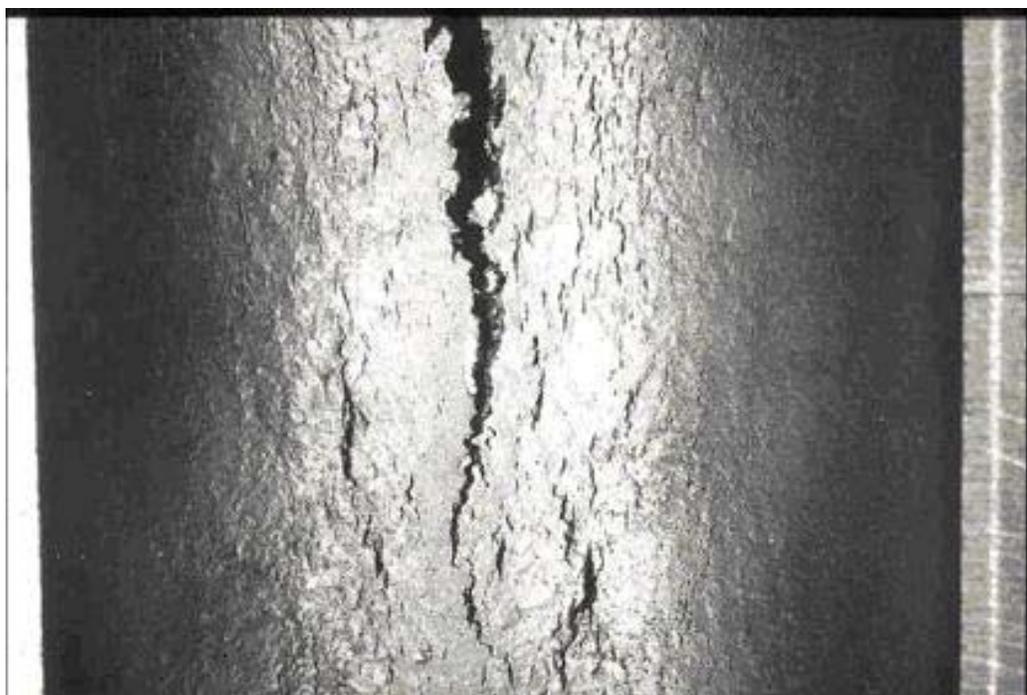
Figure 4-10 – Creep rupture of an HK40 heater tube.

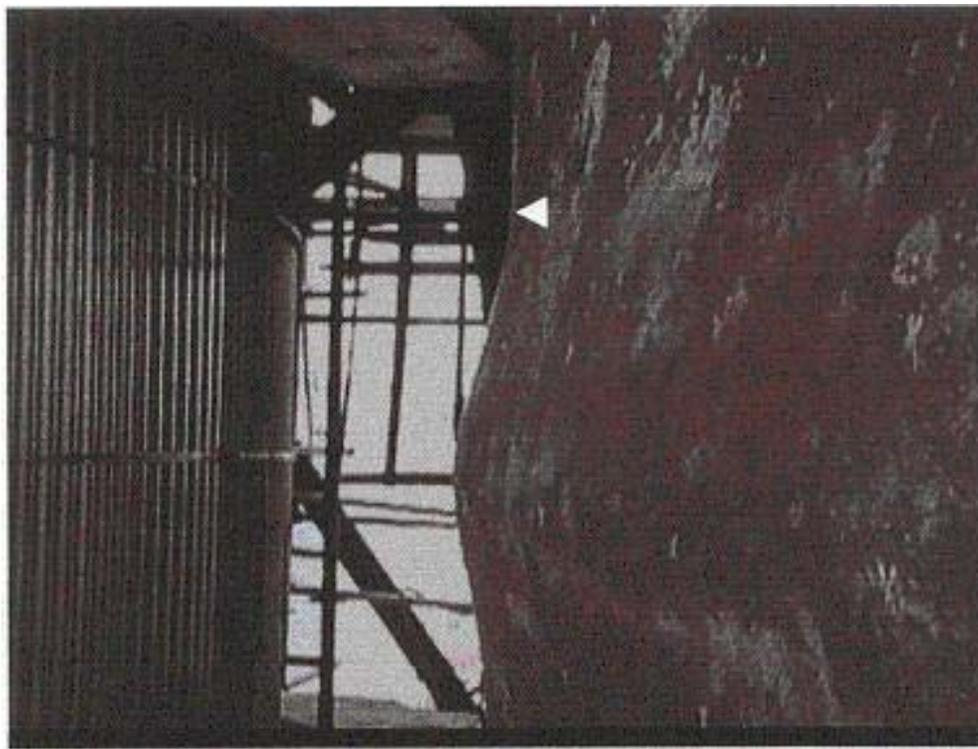
Figure 4-12 – Bulging in a skirt of a Coke Drum.

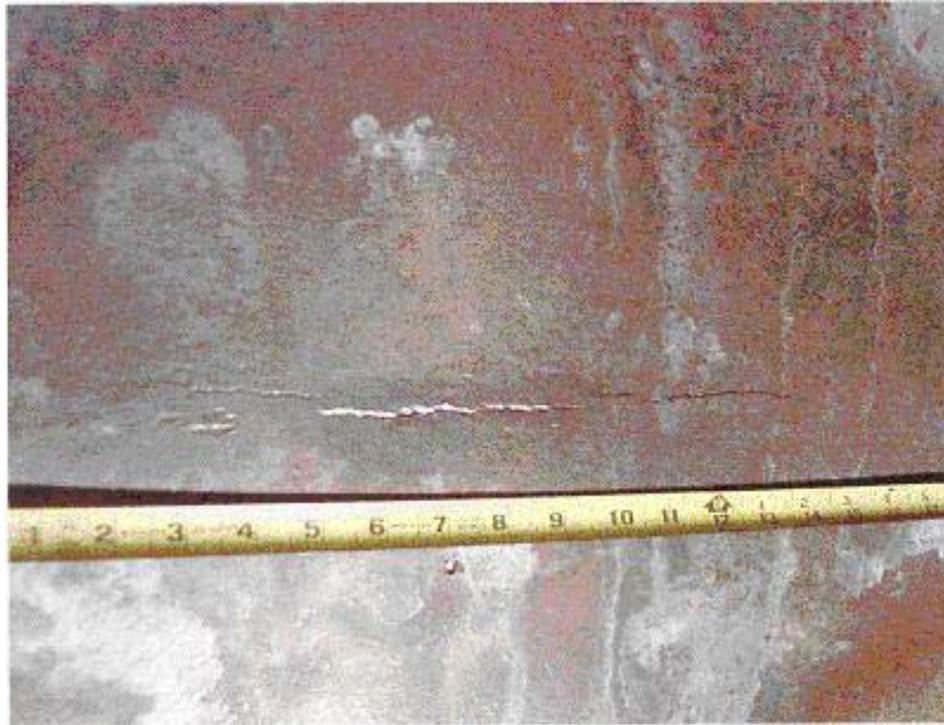
Figure 4-13 – Thermal fatigue cracking associated with bulged skirt shown in Figure 4-12.

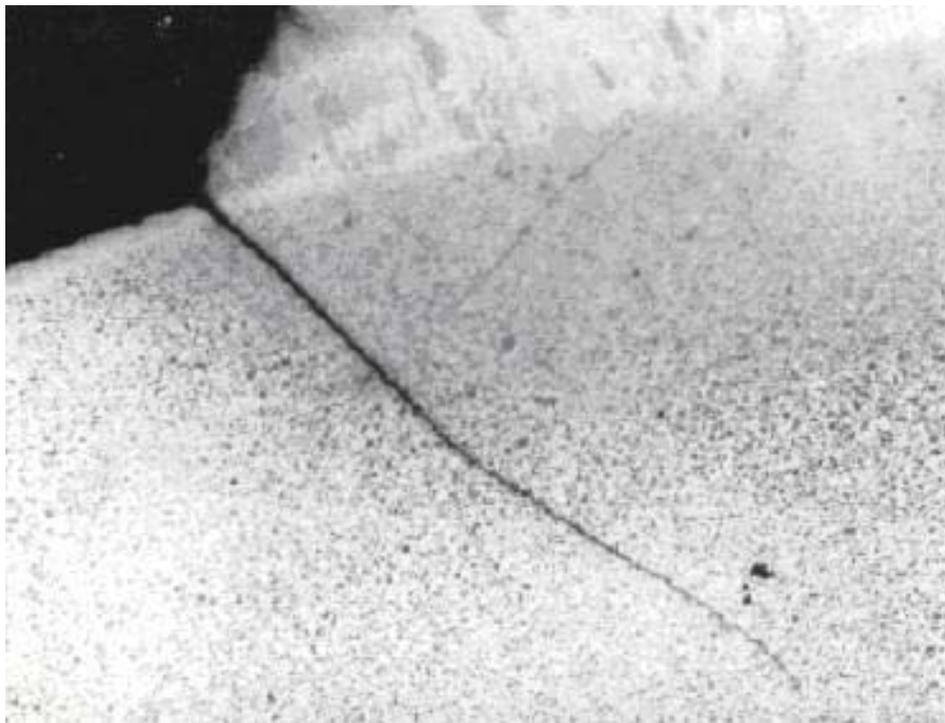
Figure 4-14 – In a carbon steel sample, metallographic section through thermal fatigue crack indicates origin (here at the toe of an attachment weld) and shape. Mag. 50x, etched.

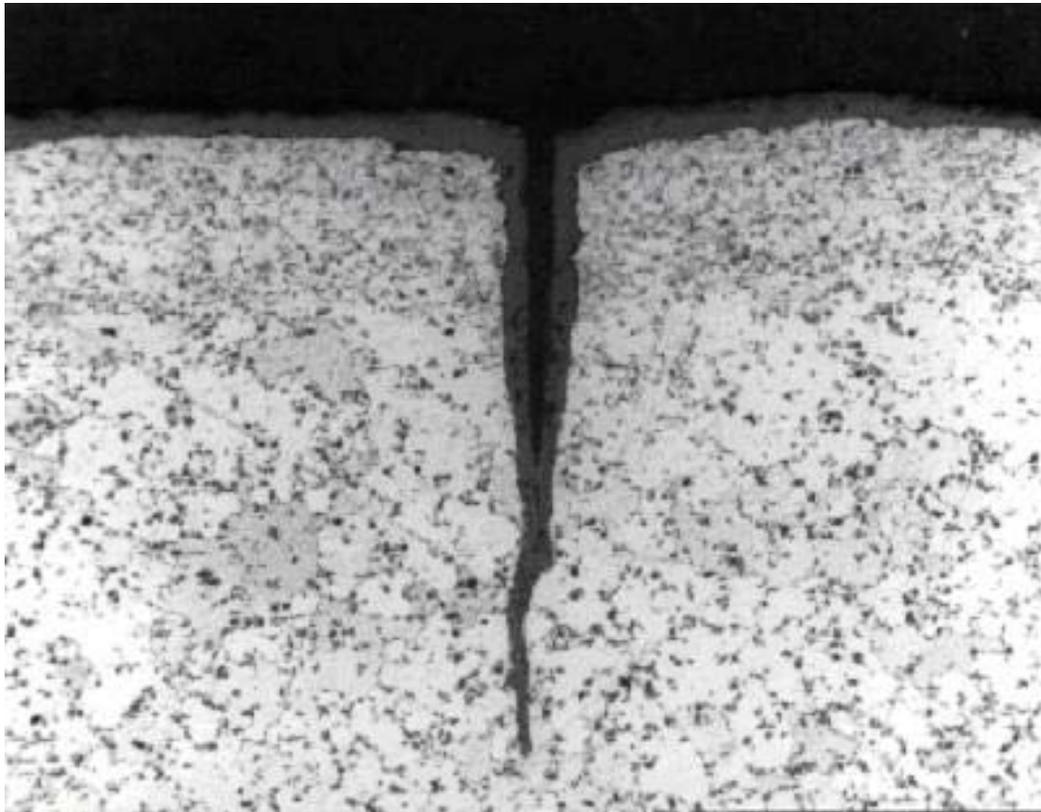
Figure 4-15 – Older cracks fill with oxide, may stop and restart (note jog part way along the crack), and do not necessarily require a change in section thickness to initiate the crack. Mag. 100x, etched.

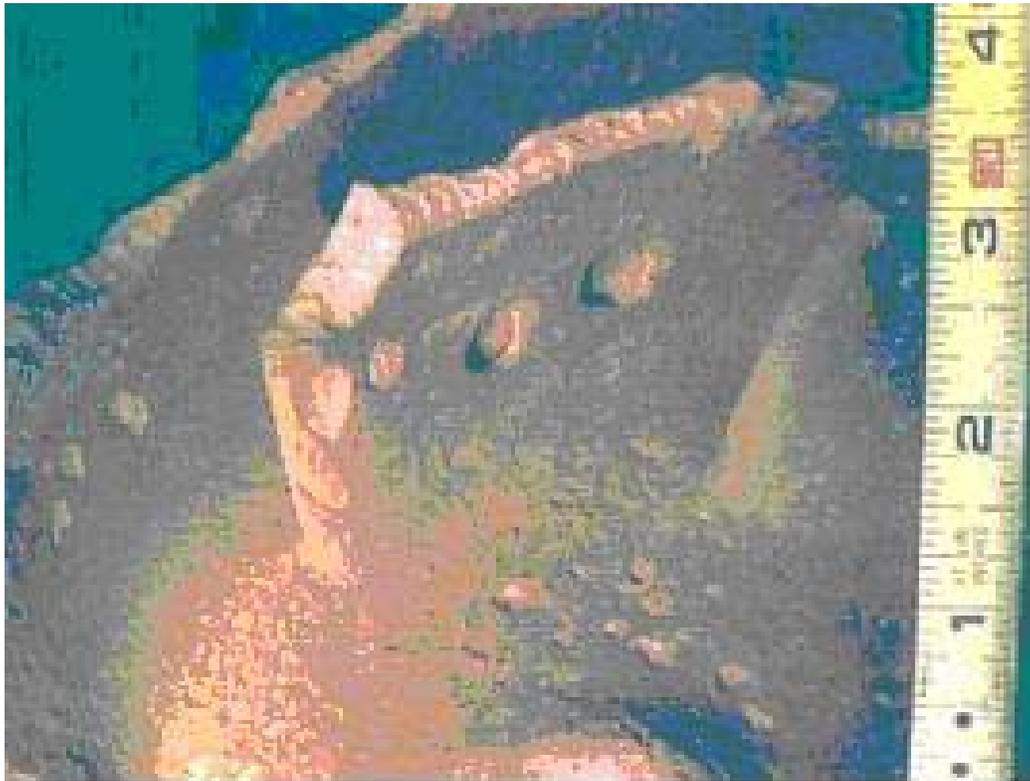
Figure 4-25 – Close-up of Figure 4-24 showing both erosion-corrosion at the vane tips and pitting on the pressure side of the vanes.

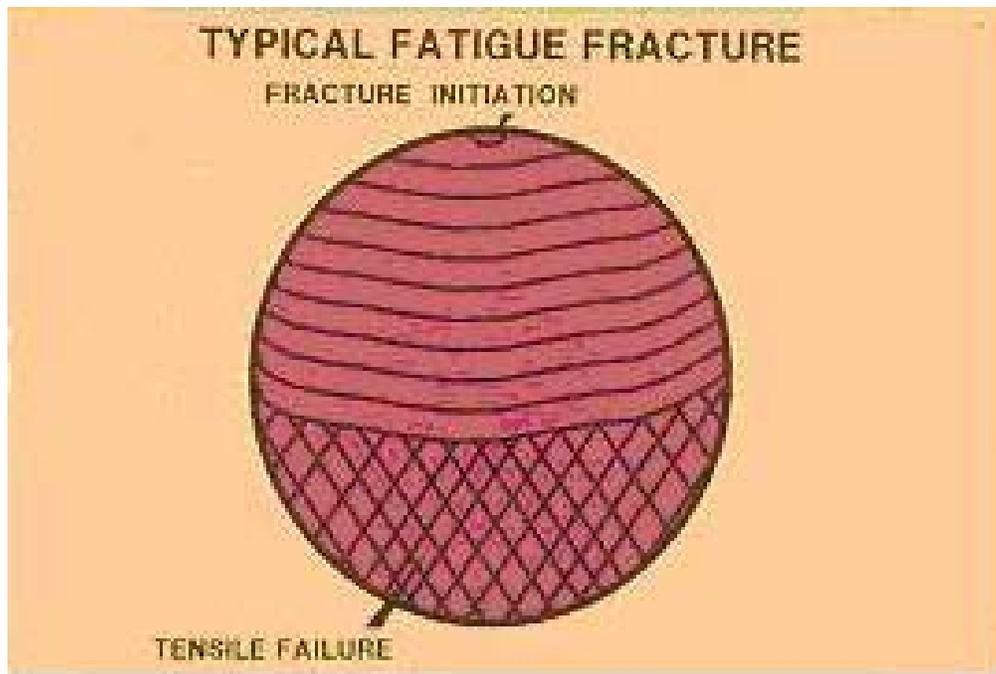
Figure 4-29 – Schematic of a fatigue fracture surface showing “beach marks”.

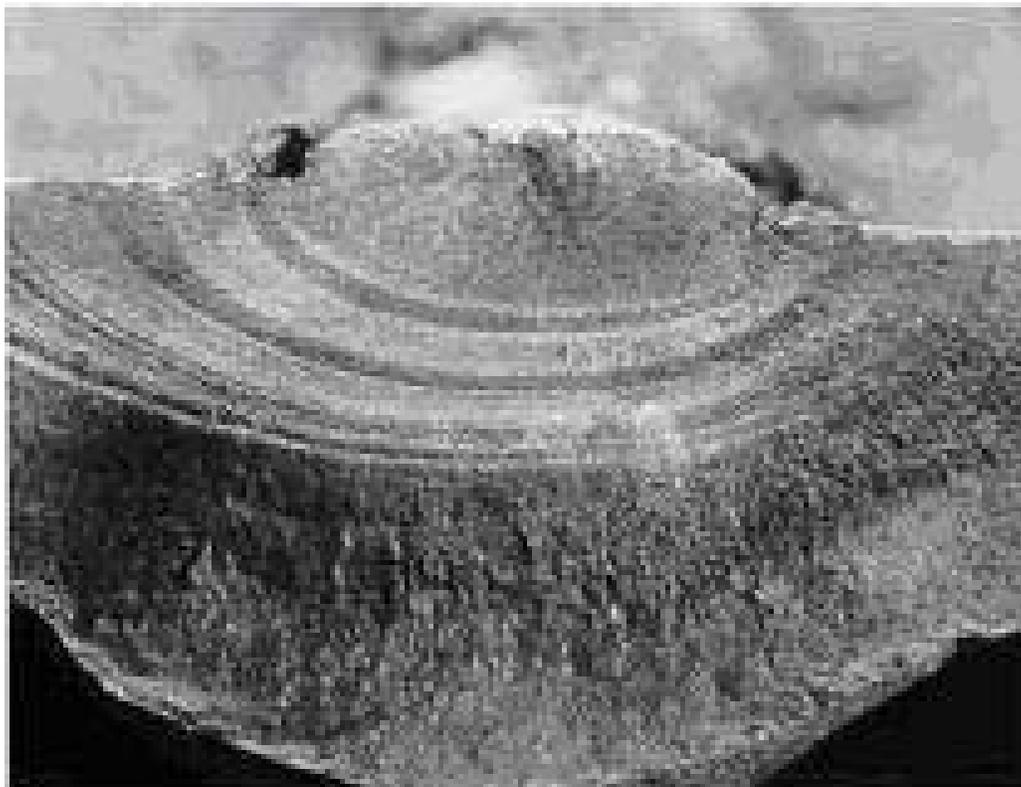
Figure 4-30 – Fatigue fracture surface of a carbon steel pipe.

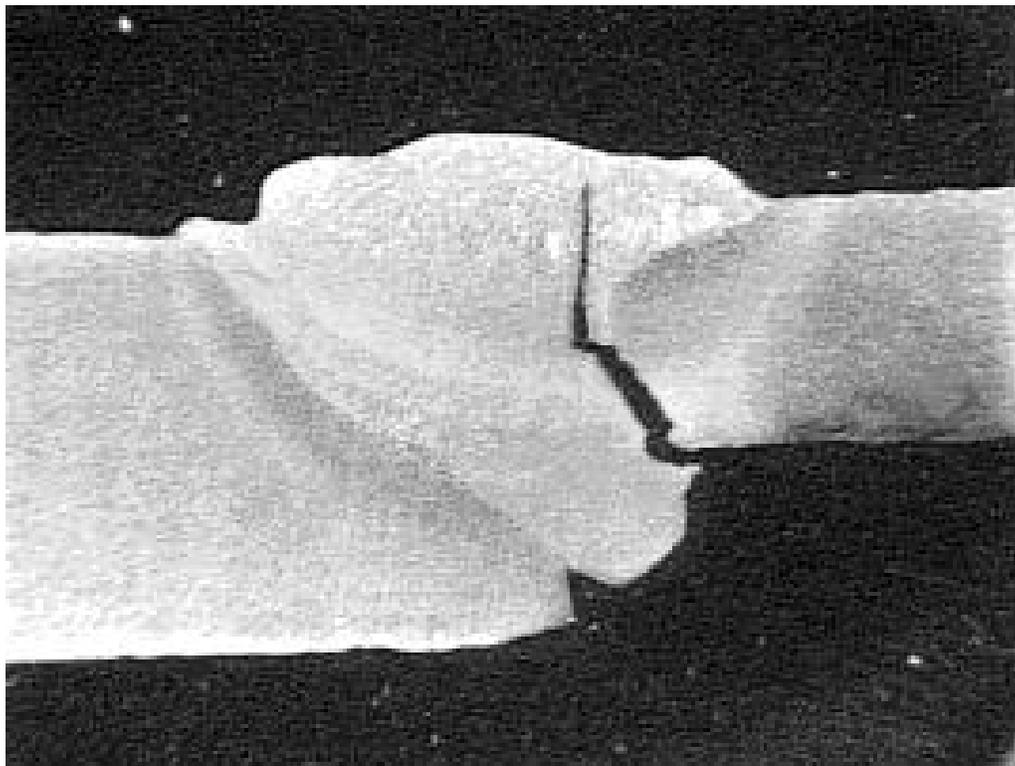
Figure 4-32 – A cross-section through the weld showing the crack location.

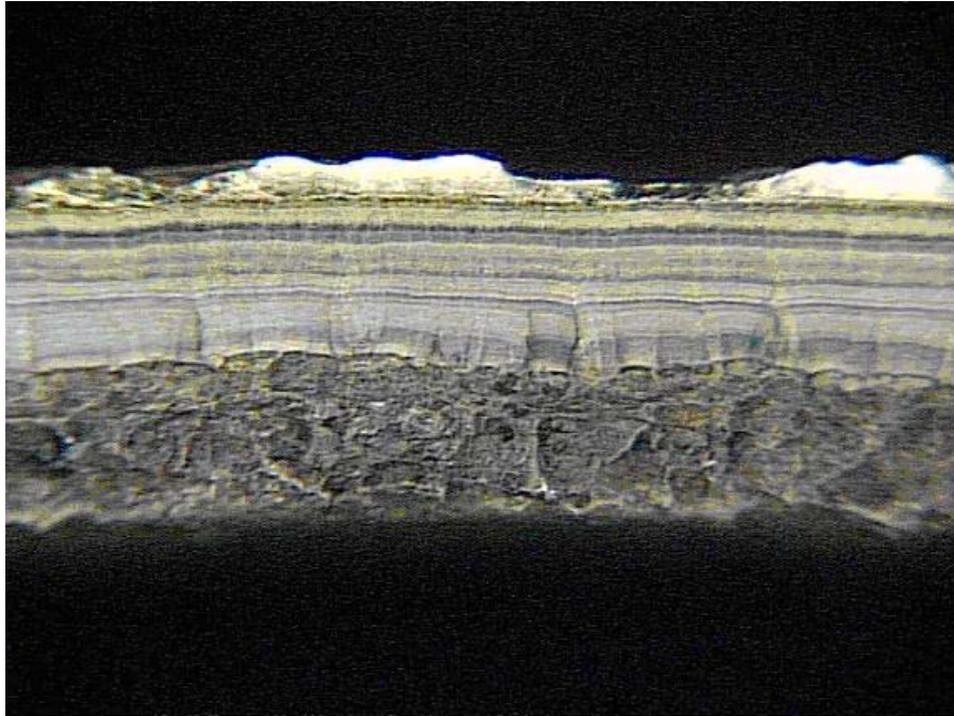
Figure 4-33 – The surface of the fracture faces of the crack shown in Figure 4-31 and Figure 4-32.

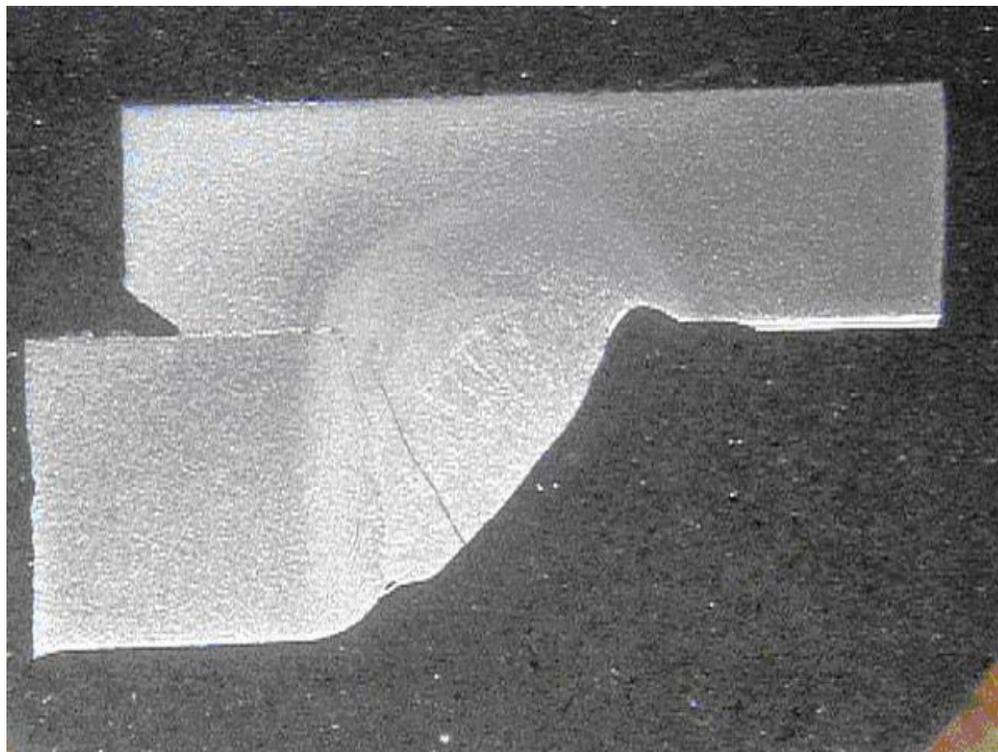
Figure 4-35 – Cross-sectional view of the crack in the socket weld in Figure 4-34.

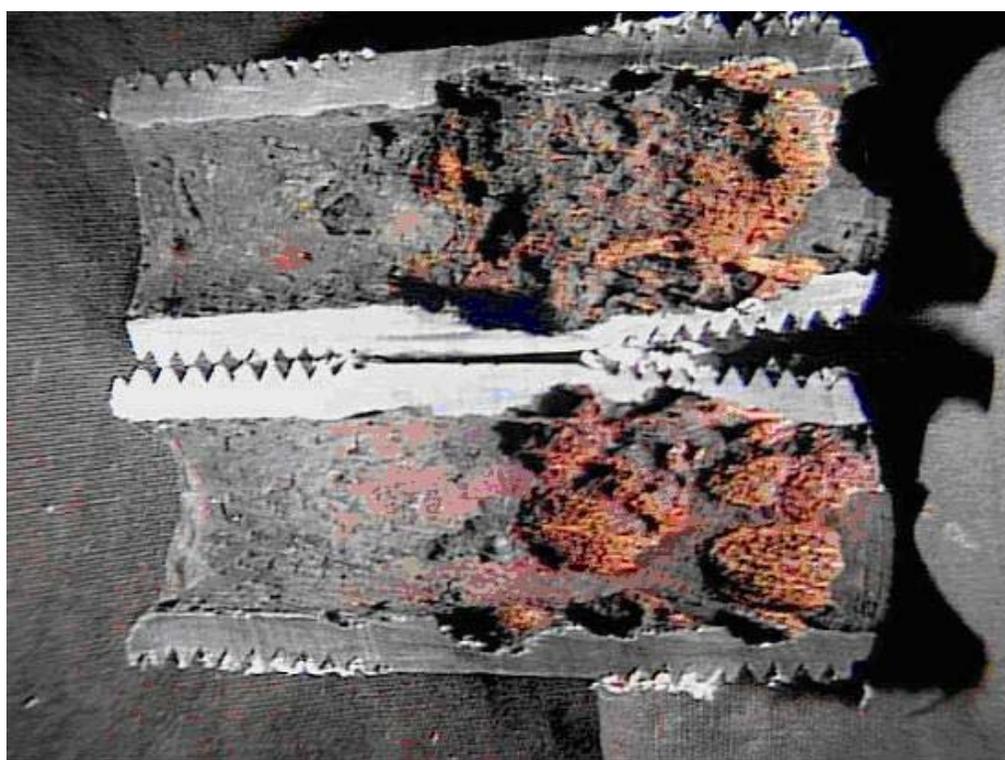
Figure 4-37 – Galvanic corrosion of a carbon steel nipple in a SS vessel in warm water service.

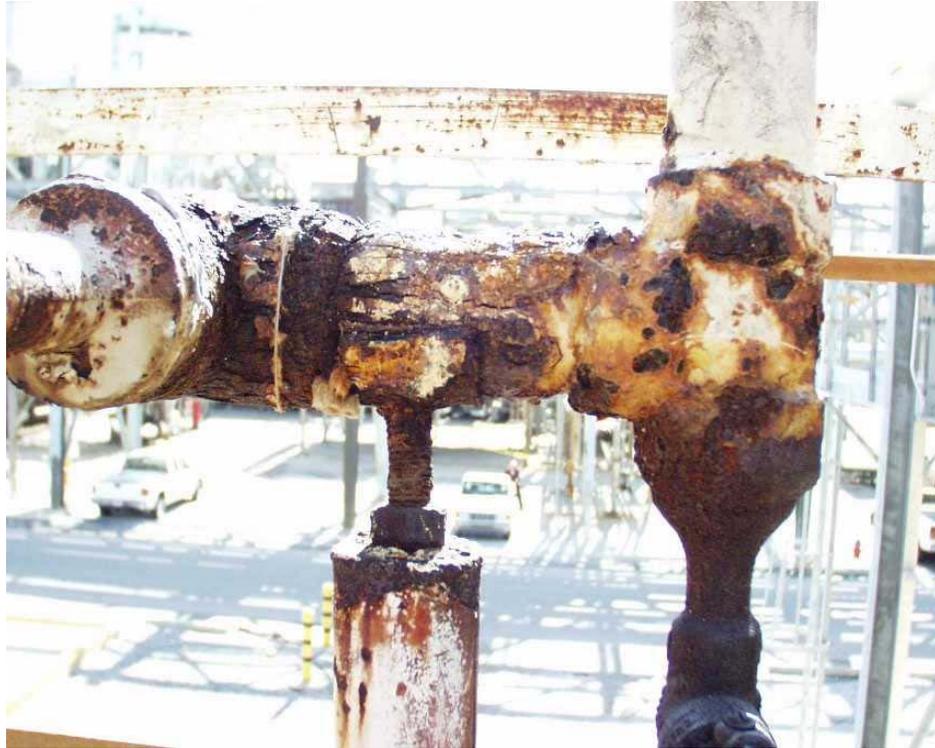
Figure 4-38 – CUI of CS level bridge

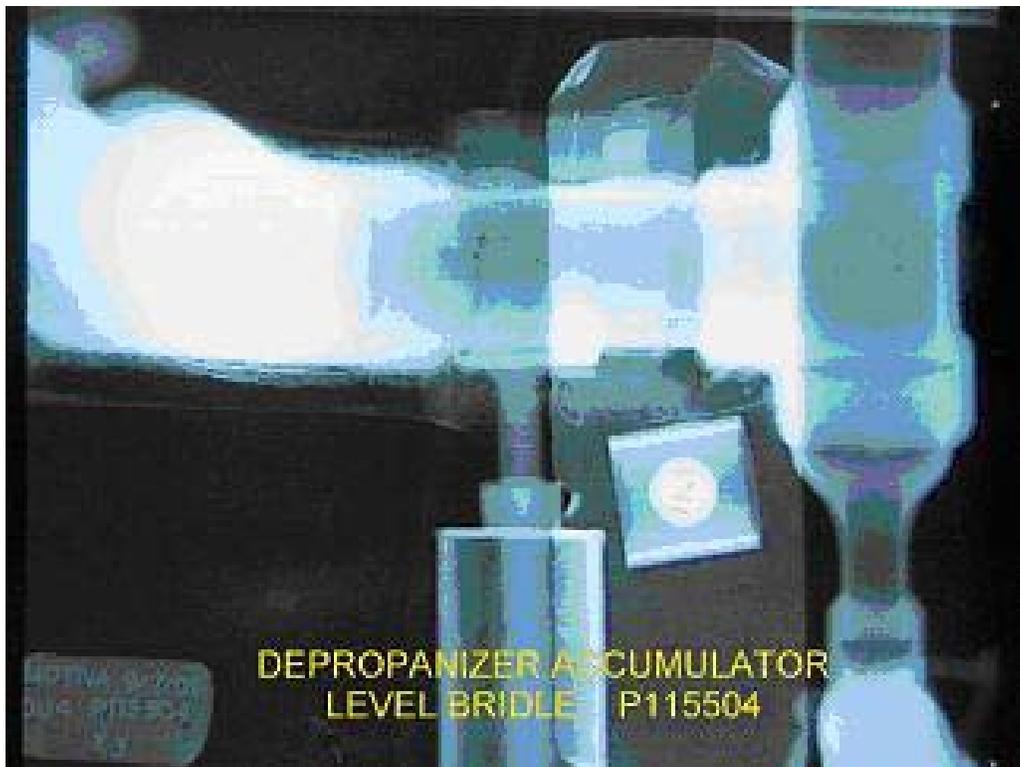
Figure 4-39 – Profile RT of level bridge in Figure 4-38.

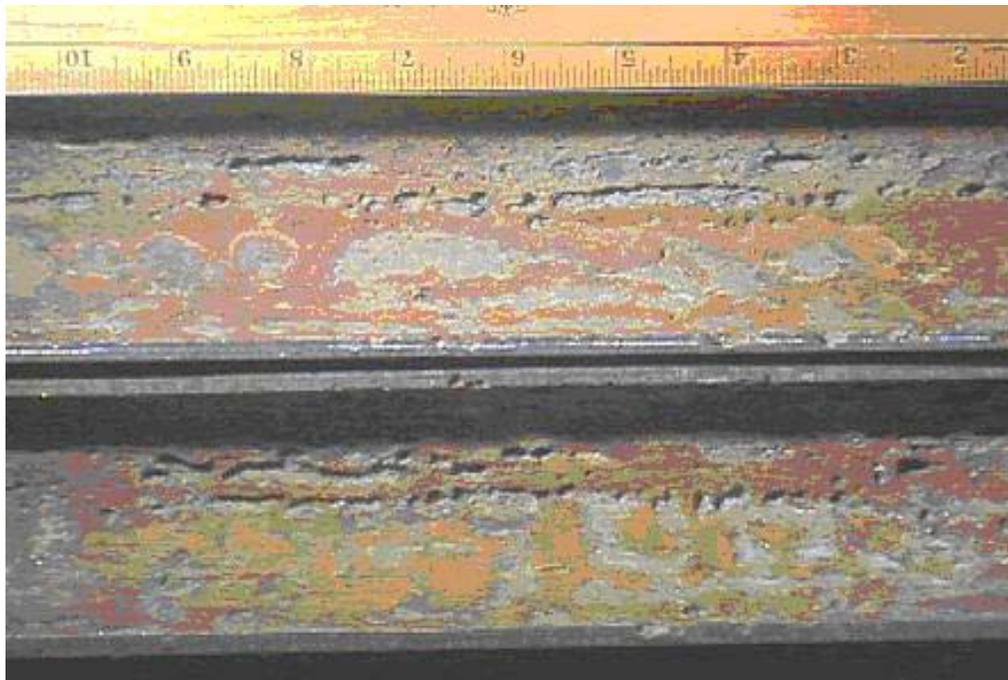
Figure 4-41 – CO₂ corrosion of a carbon steel oil and gas production flow line.

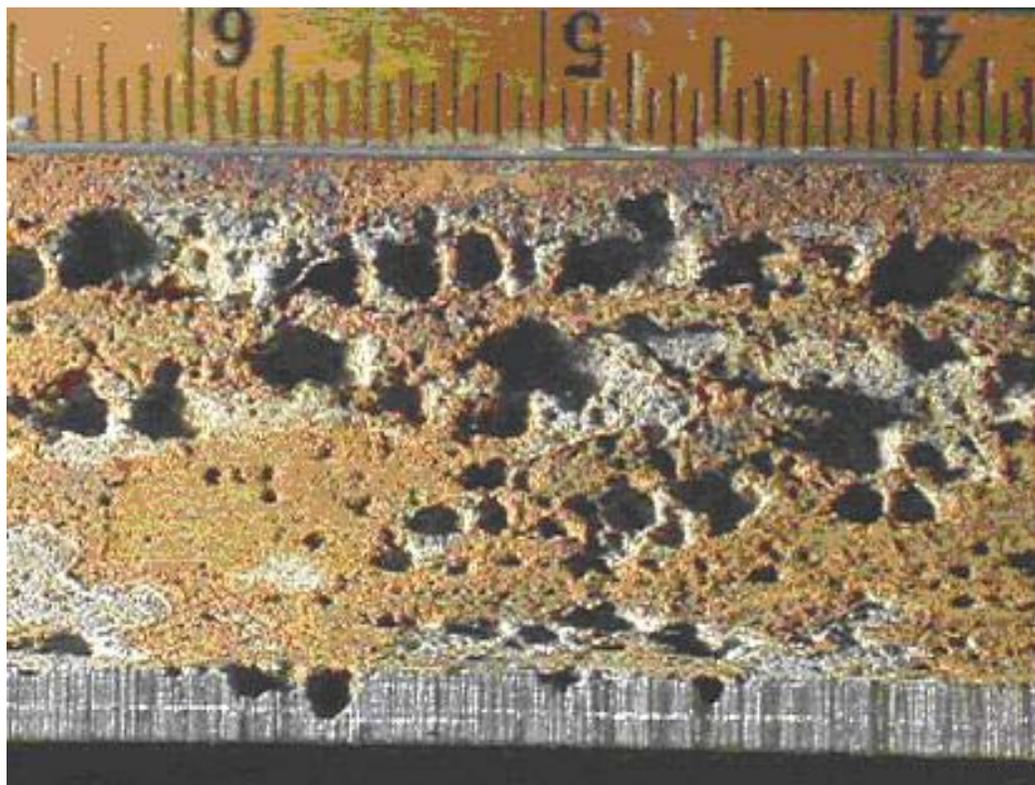
Figure 4-42 – Higher magnification view of the corrosion pits in Figure 4-41.

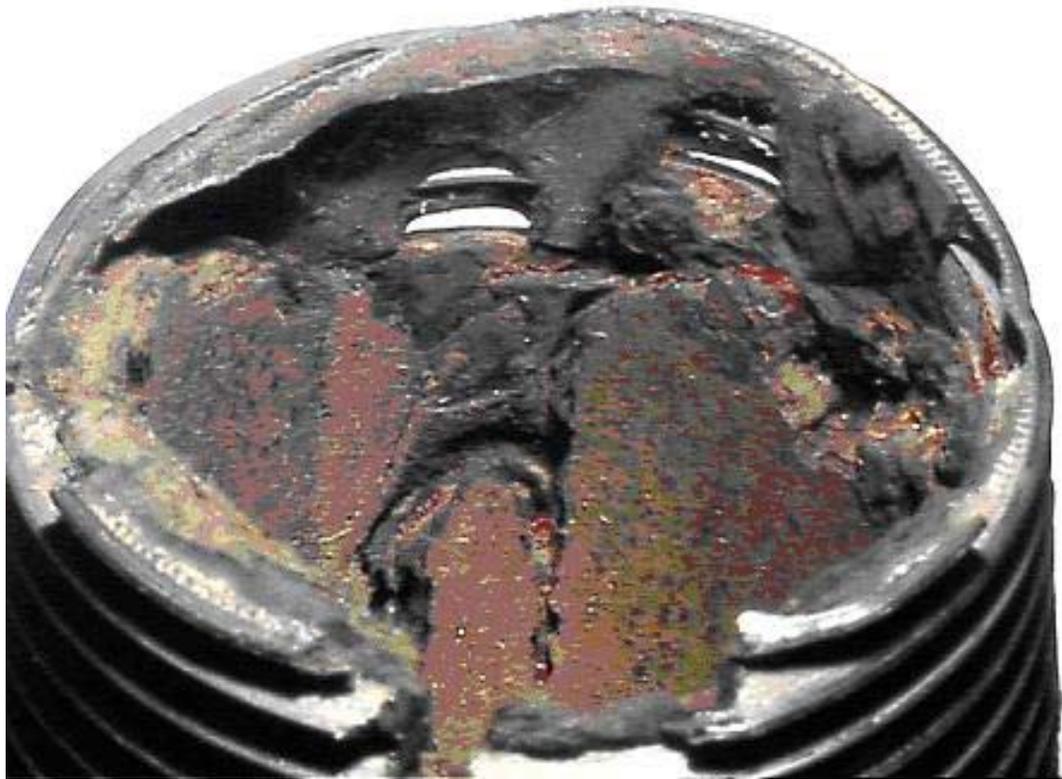
Figure 4-43 – CO₂ corrosion of CS pipe nipple in CO₂ contaminated water.

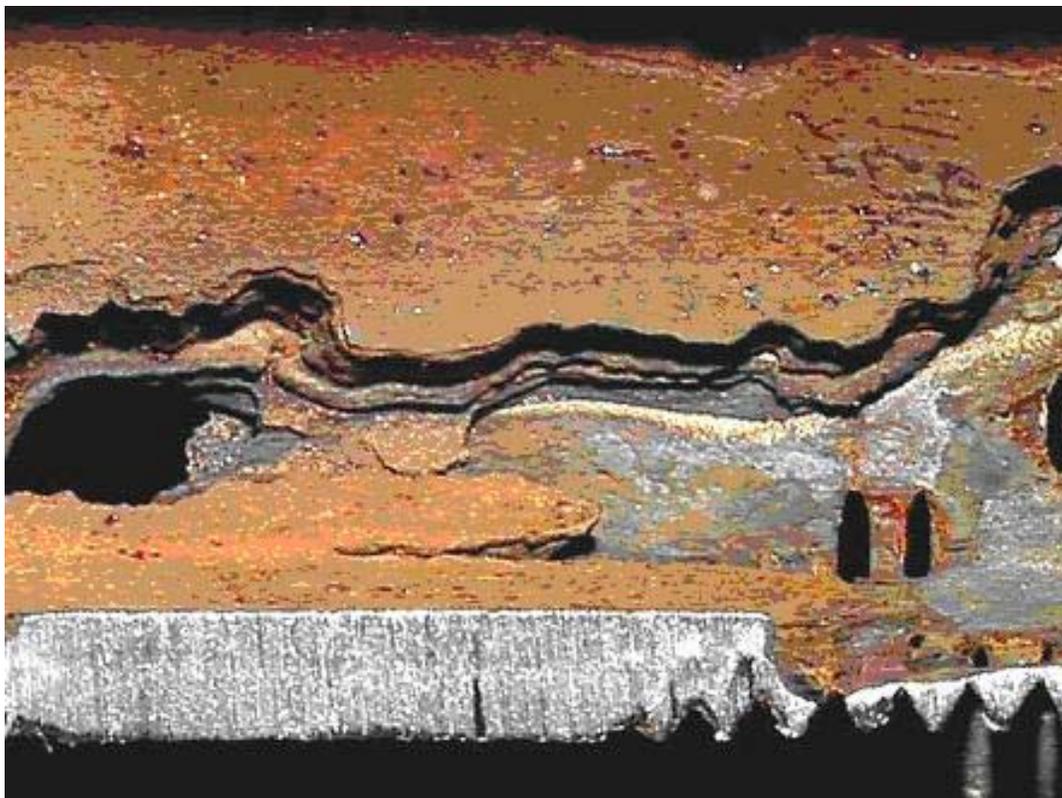
Figure 4-44 – A view inside the nipple in Figure 4-43.

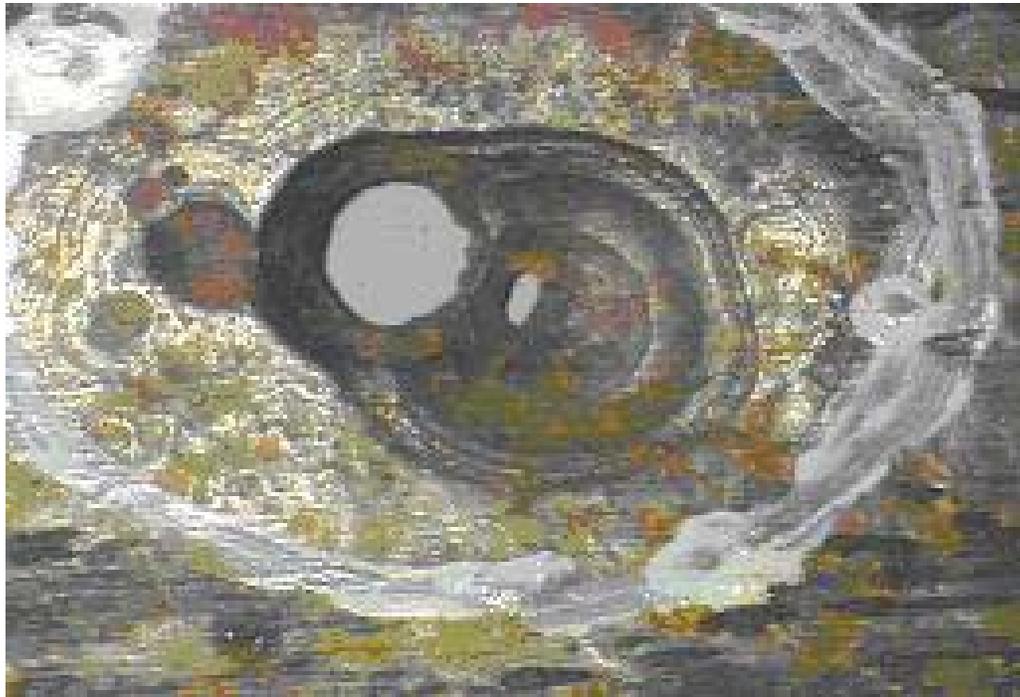
Figure 4-45 – Pitting corrosion on the I.D. of a 6-inch CS sour crude line after 2.5 years of service. Pits are approximately 1-inch to 2-inch wide. Note the halo effect in Figure 4-46.

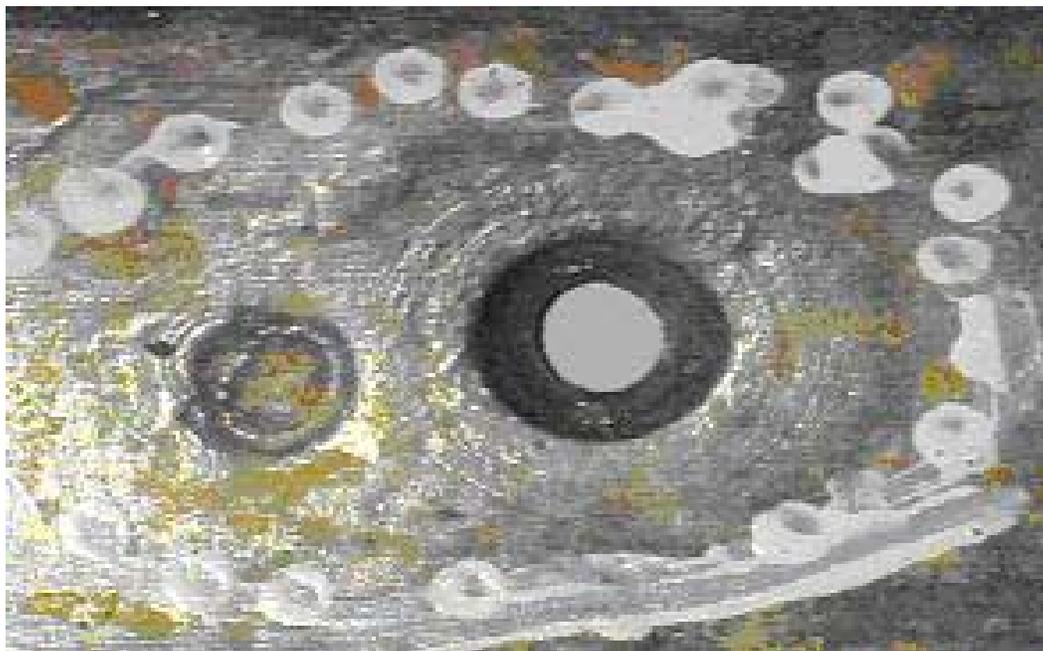
Figure 4-46 – Same pipe as Figure 4-45. Note the halo effect.

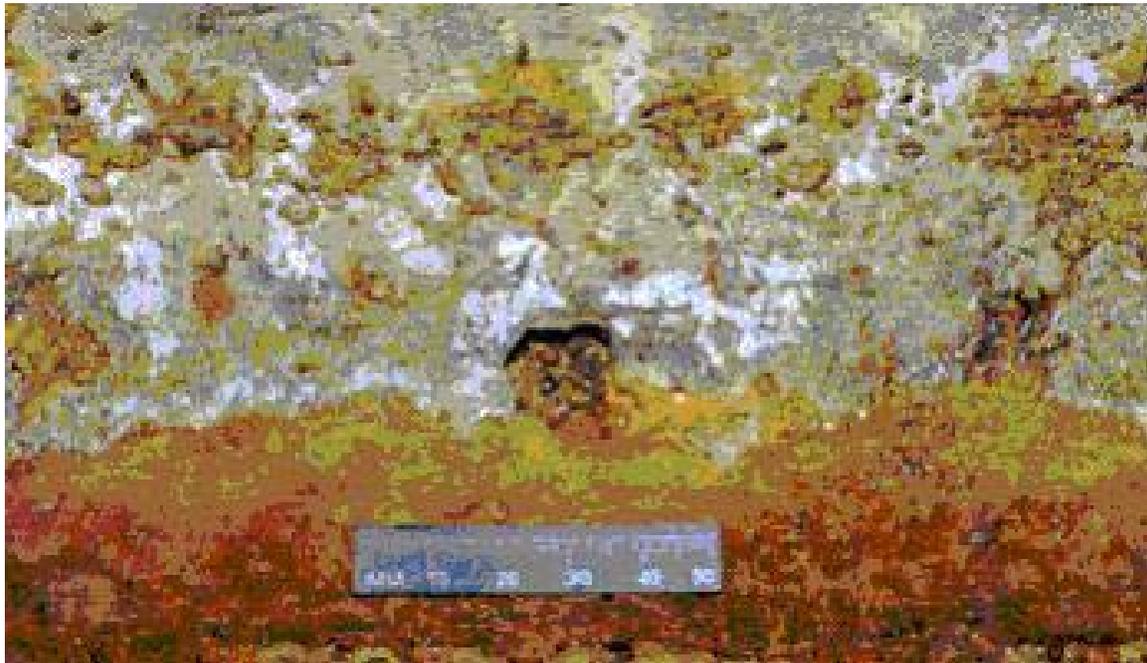
Figure 4-47 –Oil line with MIC damage beneath tubercles.

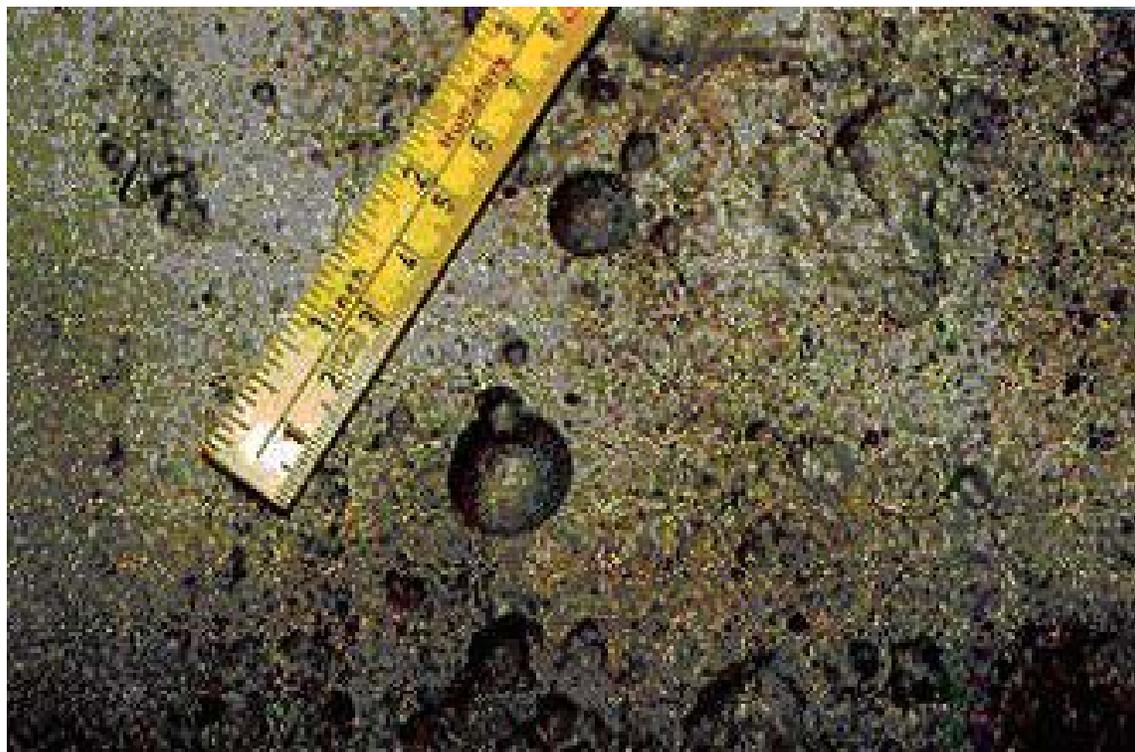
Figure 4-48 – Same oil line as Figure 4-47. Hemispherical pitting typical of MIC can be seen after grit blasting to remove the scale.

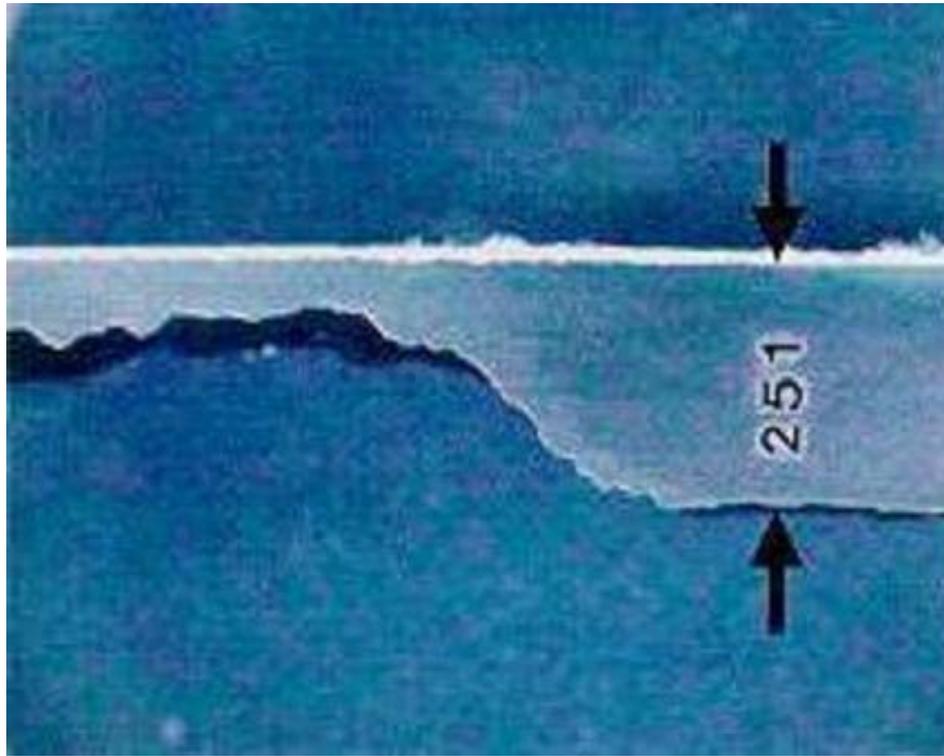
Figure 4-53 – Cross section through location (A) showing severe corrosion. The arrows point to a location that was at the original thickness.

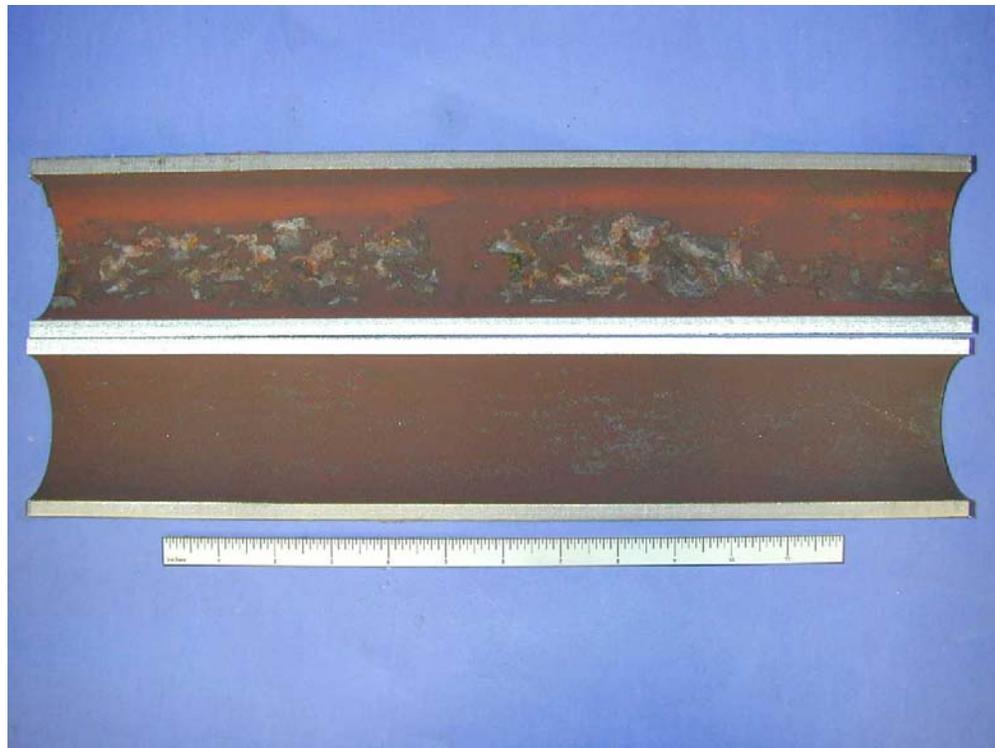
Figure 4-54 – I.D. deposits on CS boiler tube with damage due to caustic corrosion.

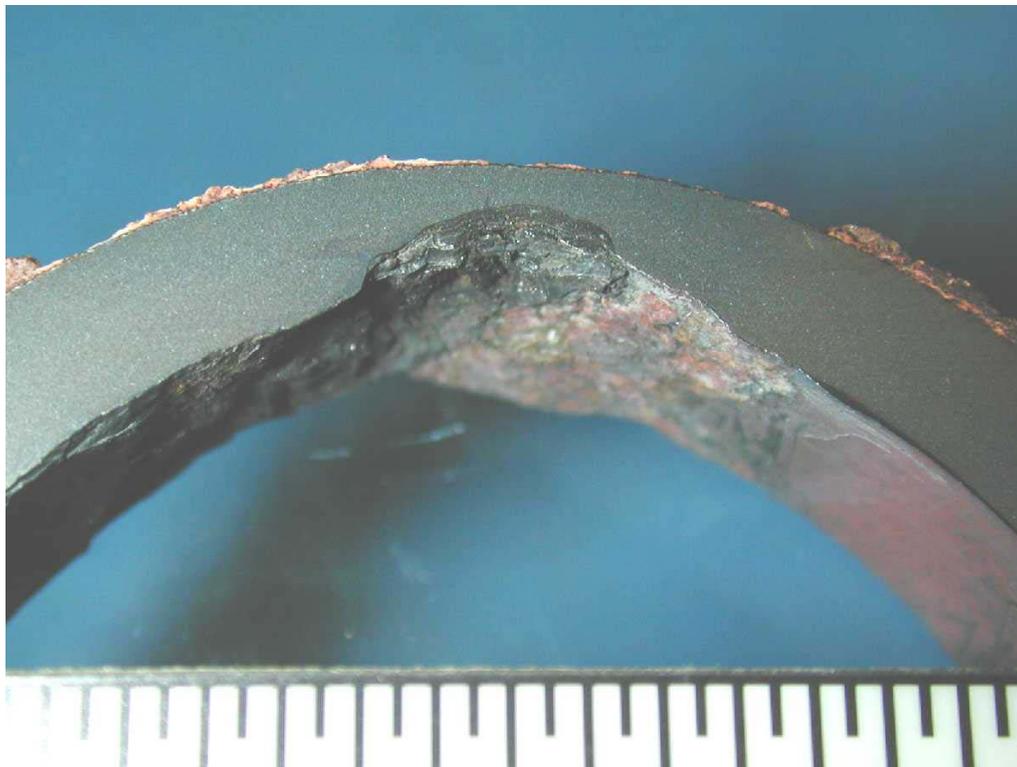
Figure 4-55 – Cross-section of tube in Figure 4-53 showing localized attack due to caustic corrosion.

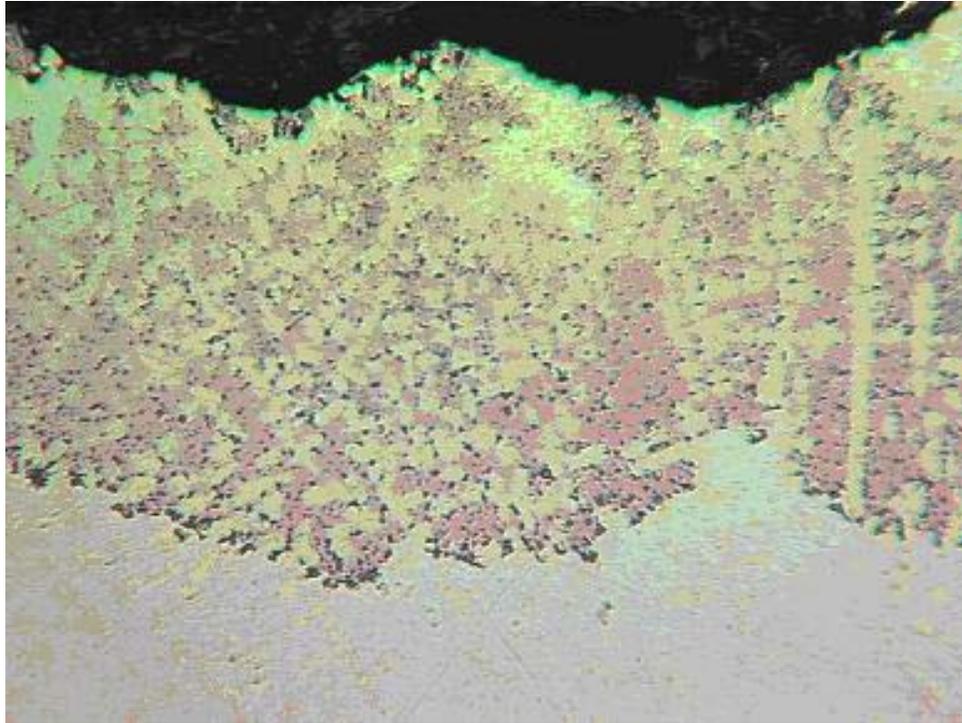
**Figure 4-56 – Cross section of a silicon-brass alloy C87500 pump impeller from stagnant fire-water service. Layer-type dezincification depleted the zinc and left this porous red color of the copper.
Mag. 50x**

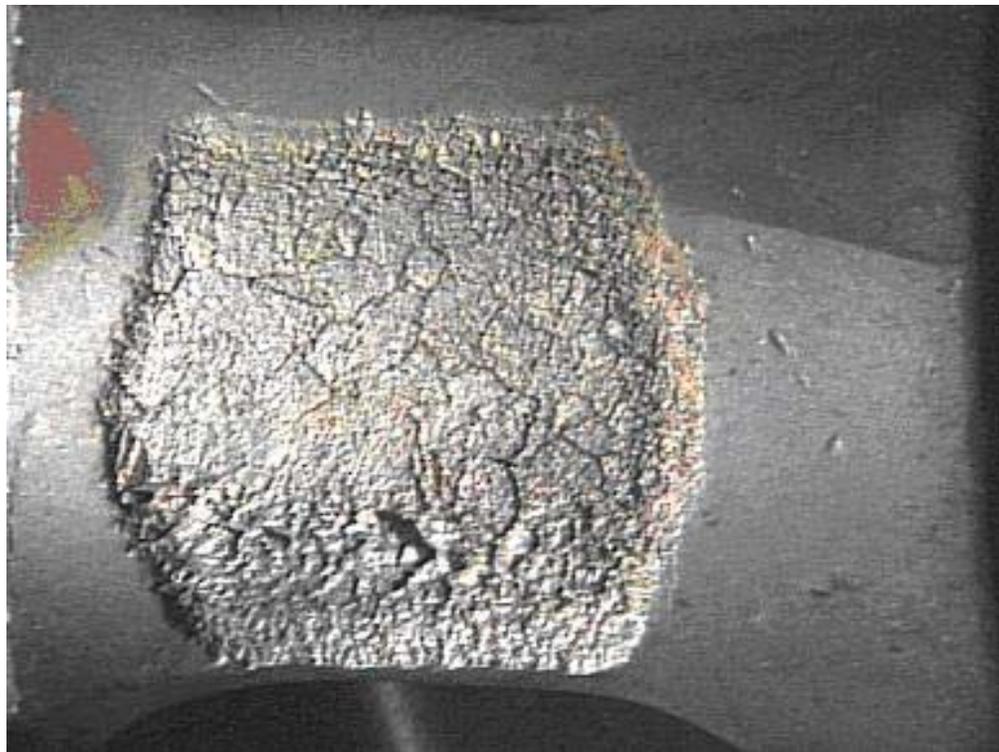
Figure 4-57 – A zone of denickelification in a Monel valve plug (at the port), due to oxygen contamination in hot hydrofluoric acid.
