Damage Mechanisms Affecting Fixed Equipment in the Refining Industry

RECOMMENDED PRACTICE 571
FIRST EDITION, DECEMBER 2003

Downstream Segment

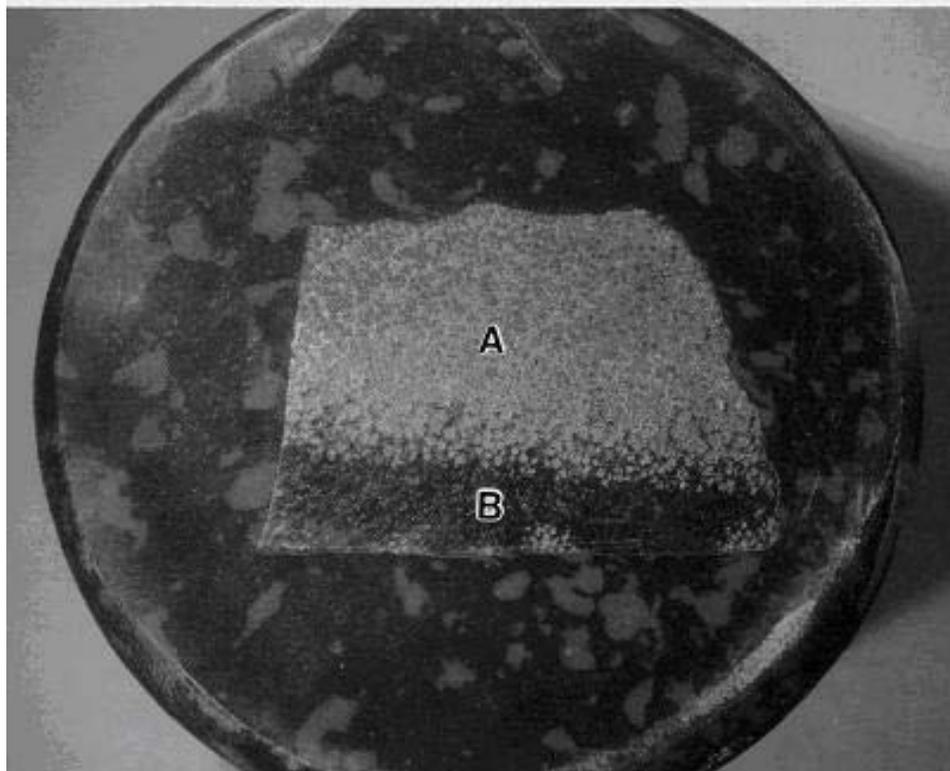
Figure 4-59 – Cross section of a gray cast iron pipe with graphitic corrosion coming from O.D. (Point B).

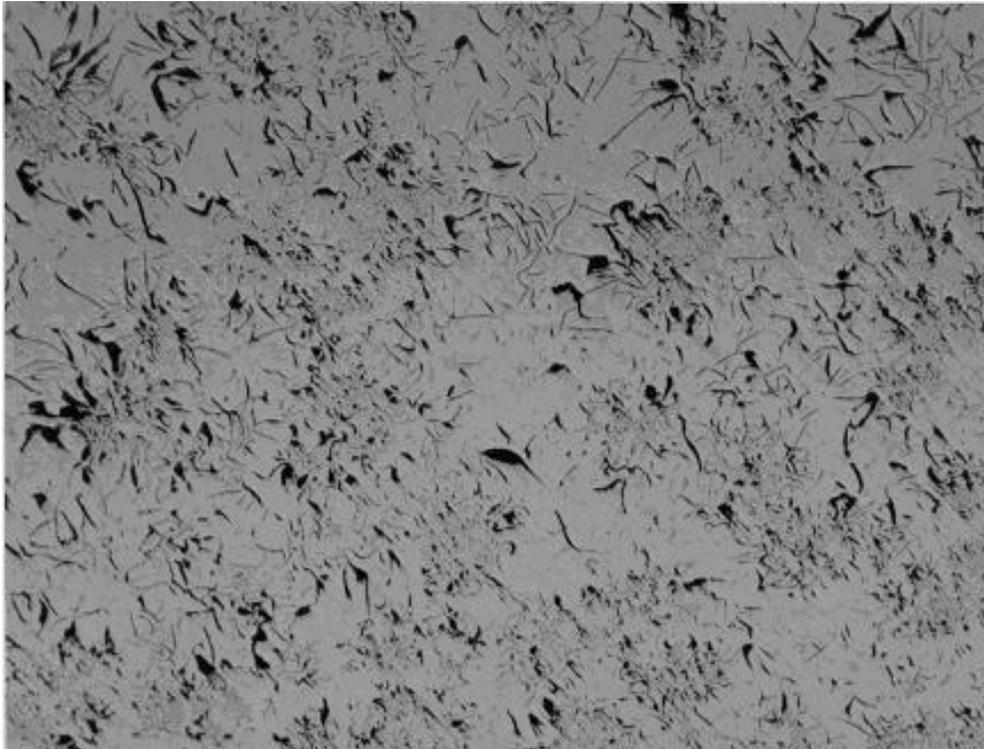
Figure 4-60 – Higher magnification view of unaffected area “A” shown in Figure 4-59.

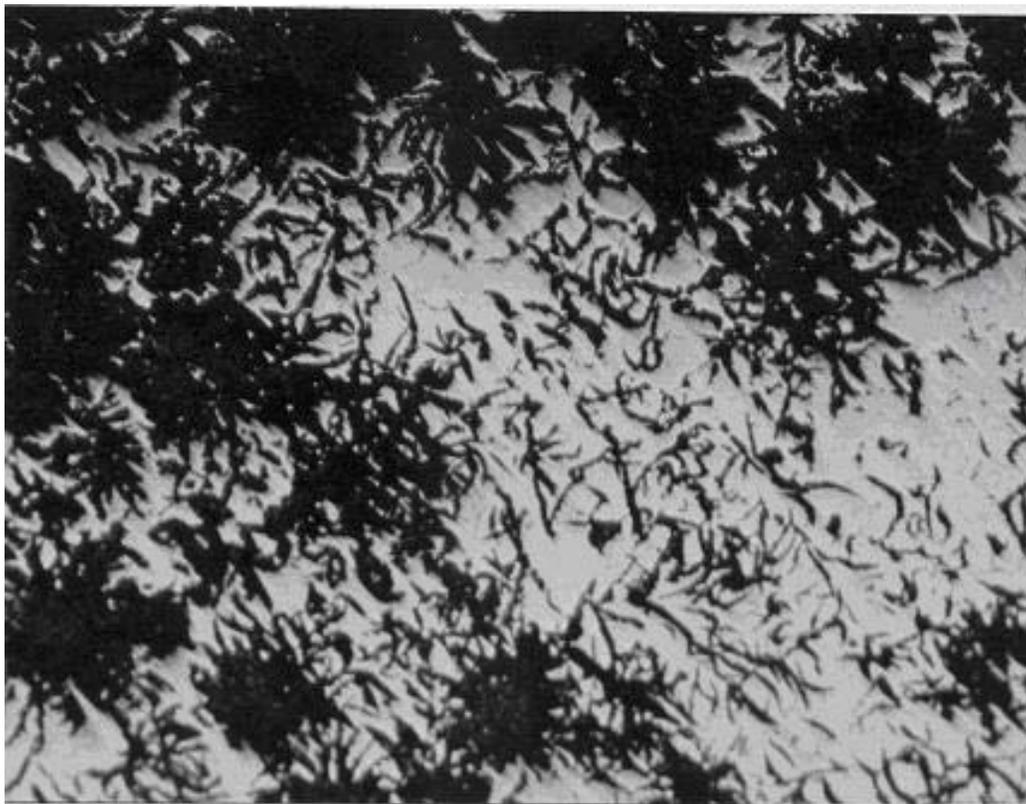
Figure 4-61 – Higher magnification view of the damage from shown in 4-59 (area “B”).

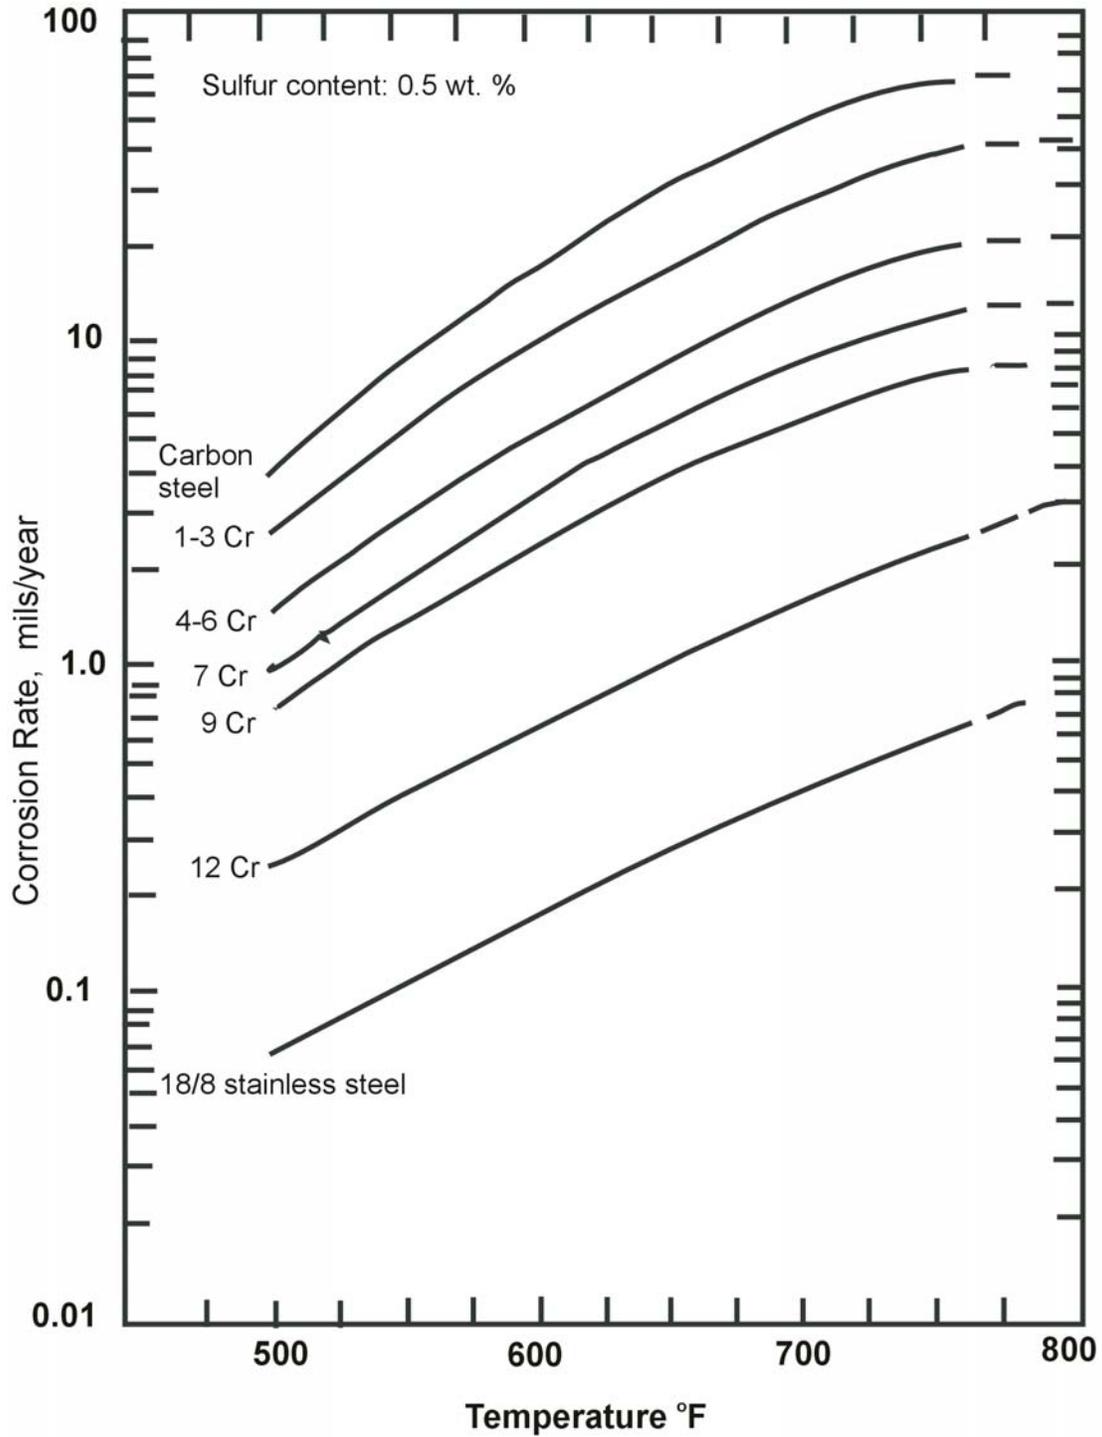
Figure 4-65 – Modified McConey curves showing typical effect of temperature on high temperature sulfidation of steels and stainless steels. (Ref. 3)

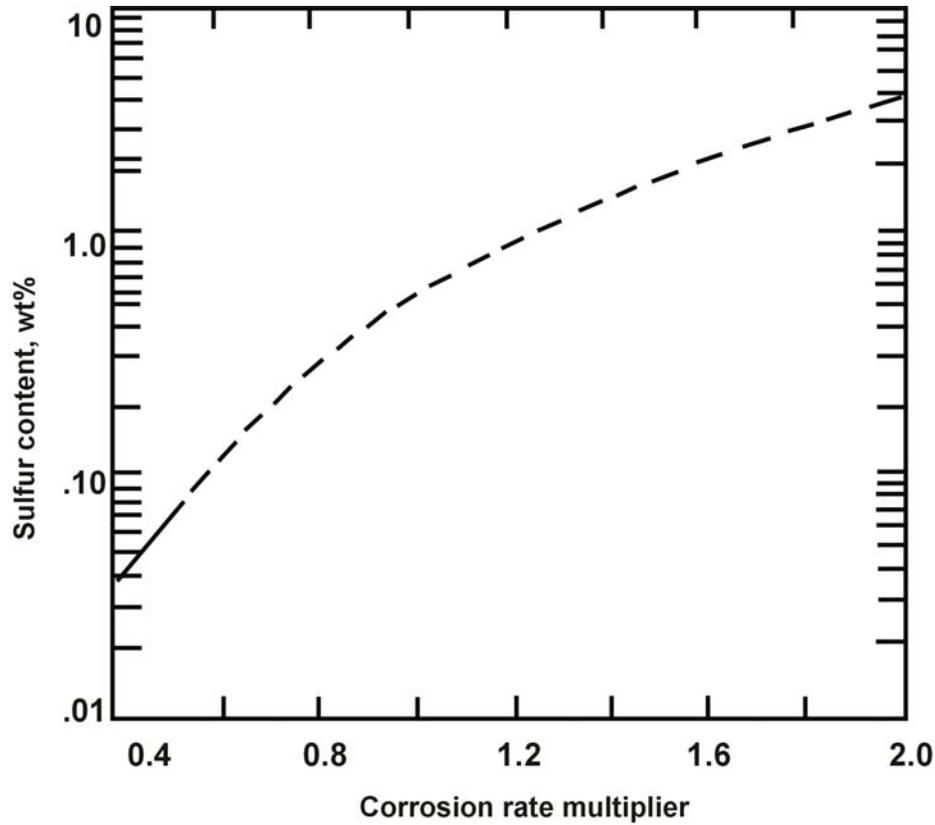
Figure 4-66 – Multiplier for corrosion rates in Figure 4-65 based on differing sulfur content of process fluid. (Ref. 3)

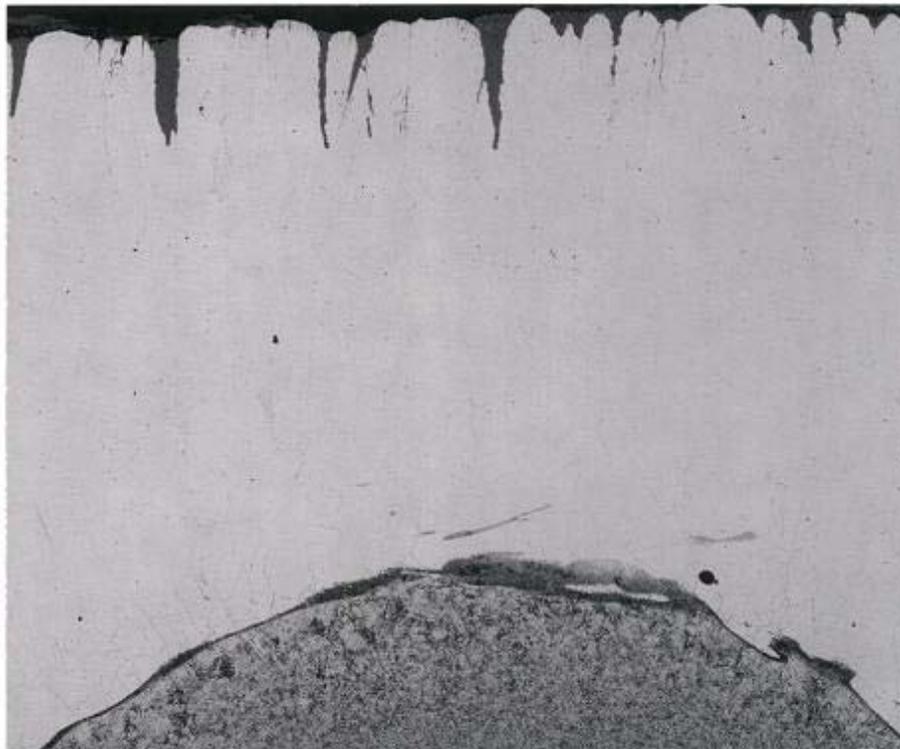
Figure 4-73 – On waterwall tubes, even with a corrosion-resistant weld-overly, circumferential cracking will develop. Mag. 37½x, etched.

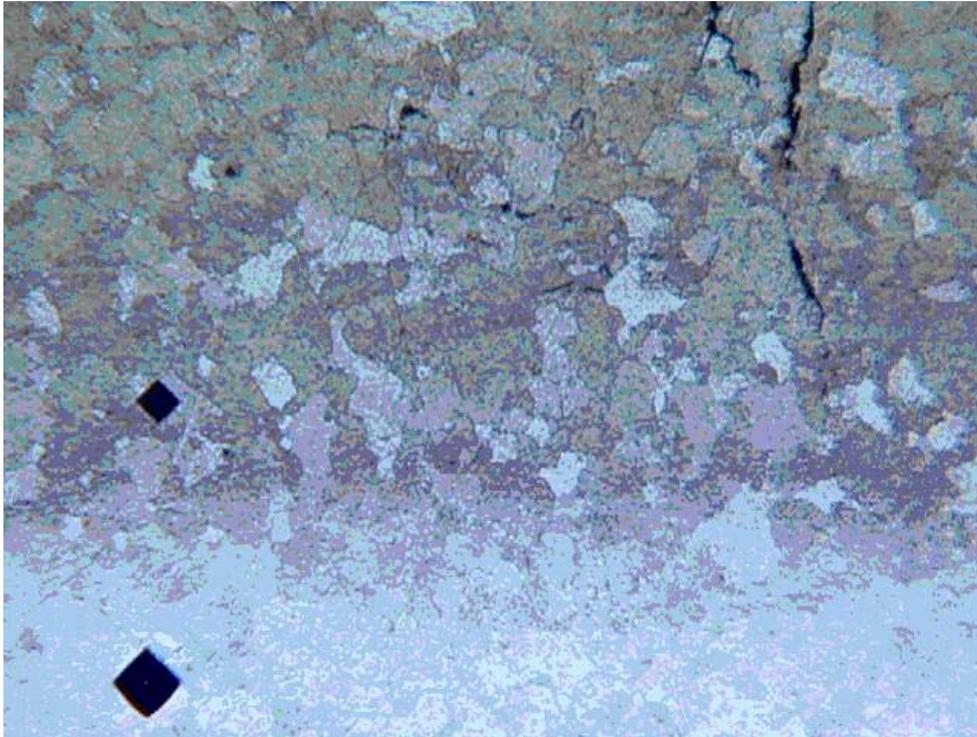
Figure 4-76 – A higher magnification photomicrograph showing the diamond-shaped hardness indentations in the hard nitrided layer (540 BHN) versus the softer base metal (210 BHN). Mag. 150x

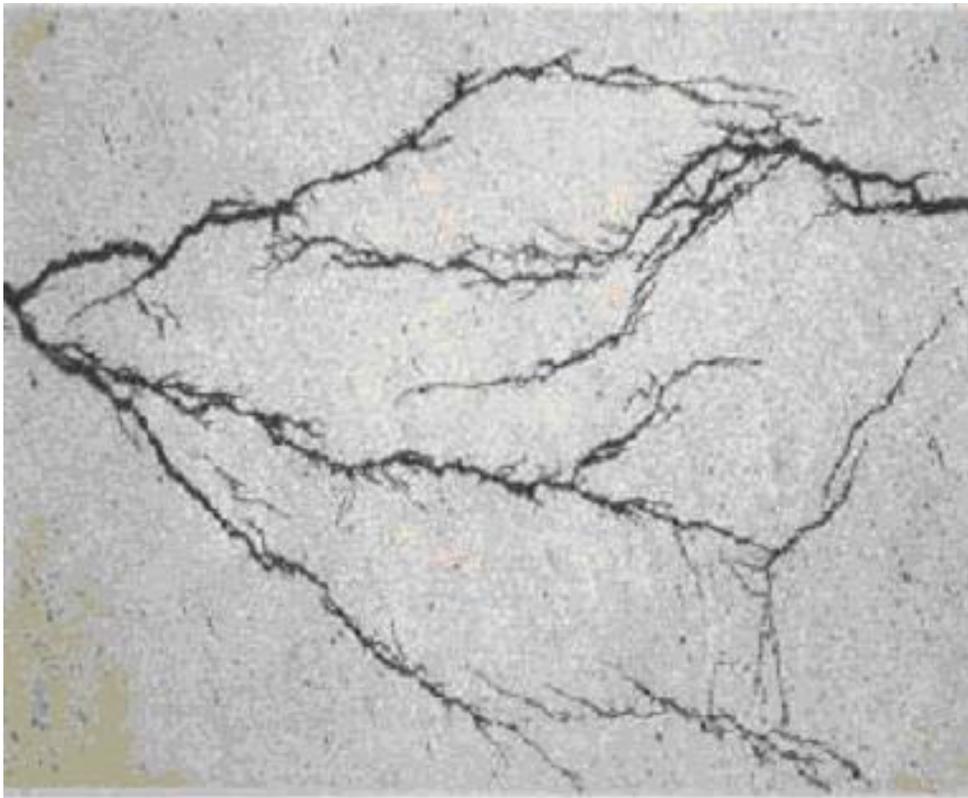
Figure 4-81 – Photomicrograph of a cross-section of sample in Figure 4-79 showing fine branching cracks. (Unetched, Mag. 50x)

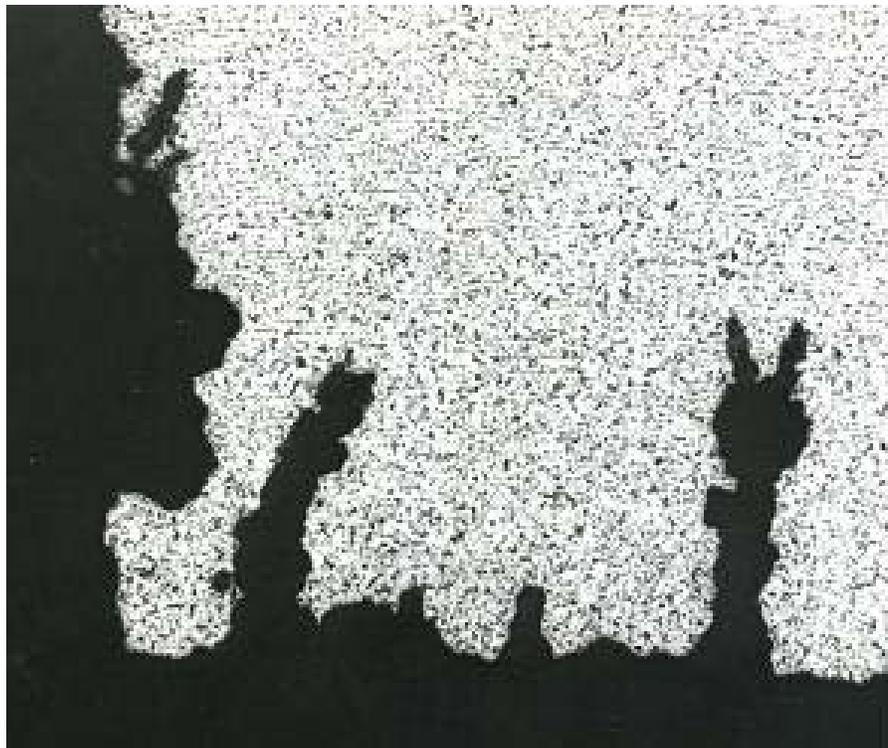
Figure 4-84 – Photomicrograph showing the crack morphology that is rounded with multiple lobes, and may branch to form "rabbit ears." (Mag. 25x, etched.)

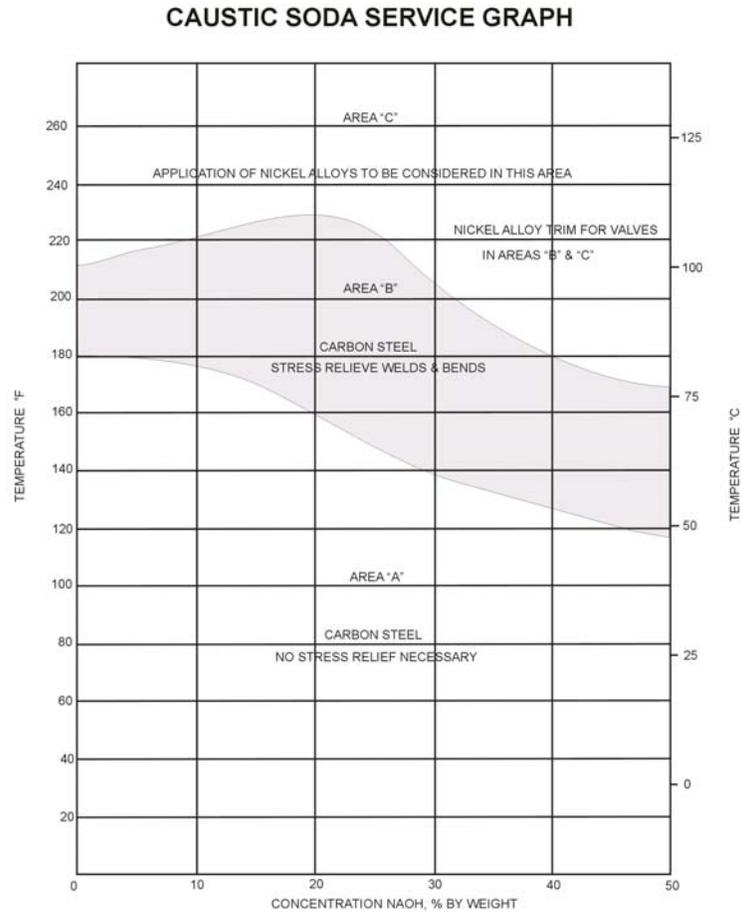
Figure 4-85 – Recommended operating limits for carbon steel in caustic service. (Ref. 1)

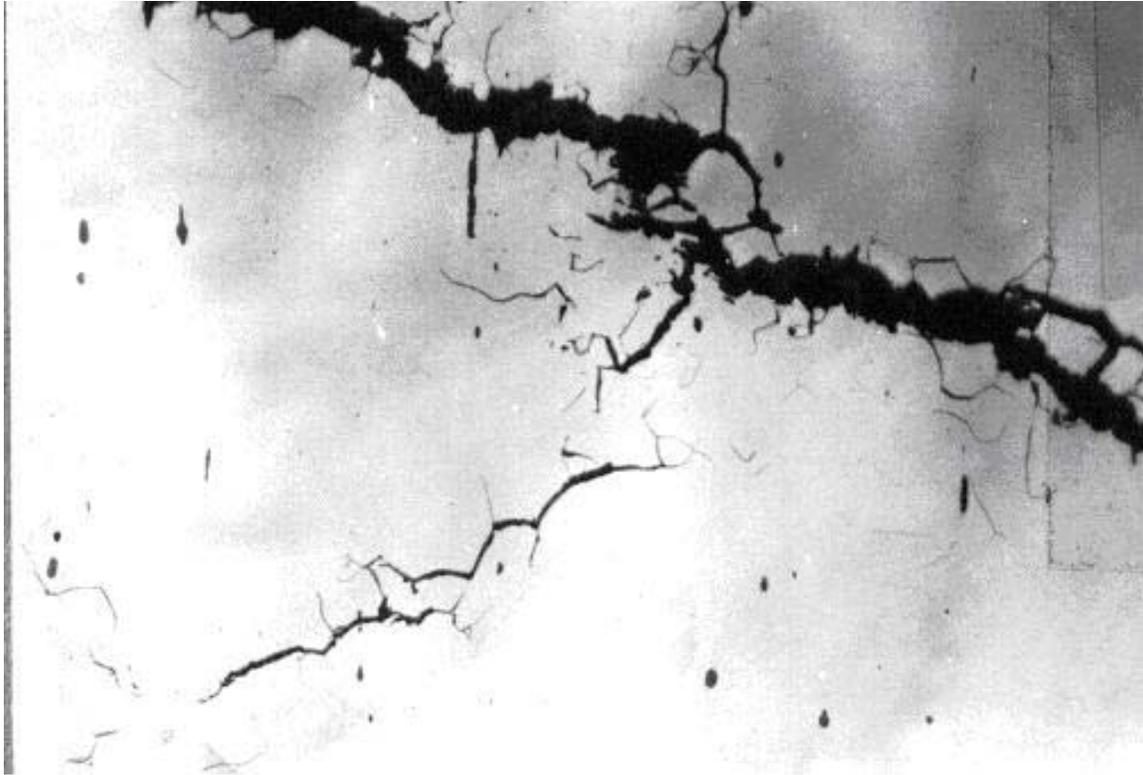
Figure 4-89 – Photomicrograph of a crack in the tubesheet shown in Figure 4-88.

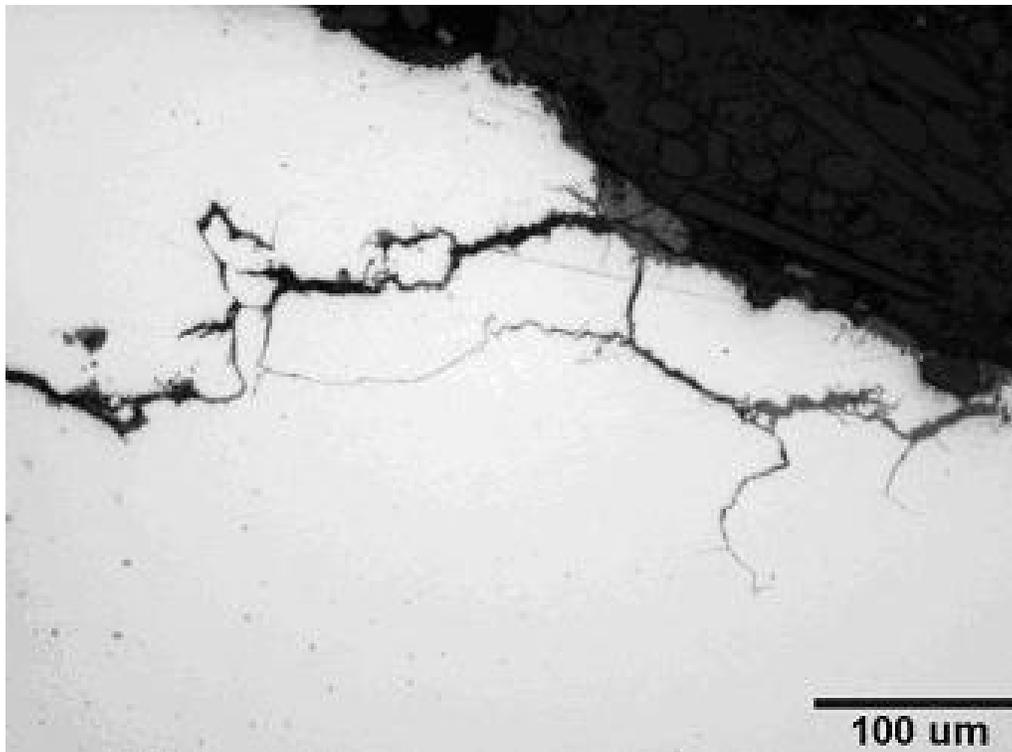
Figure 4-90 – Photomicrograph of caustic cracking initiating on the I.D. of a carbon steel socket weld in a non-PWHT'd piping in a suction drum downstream of a caustic scrubber. Unetched.

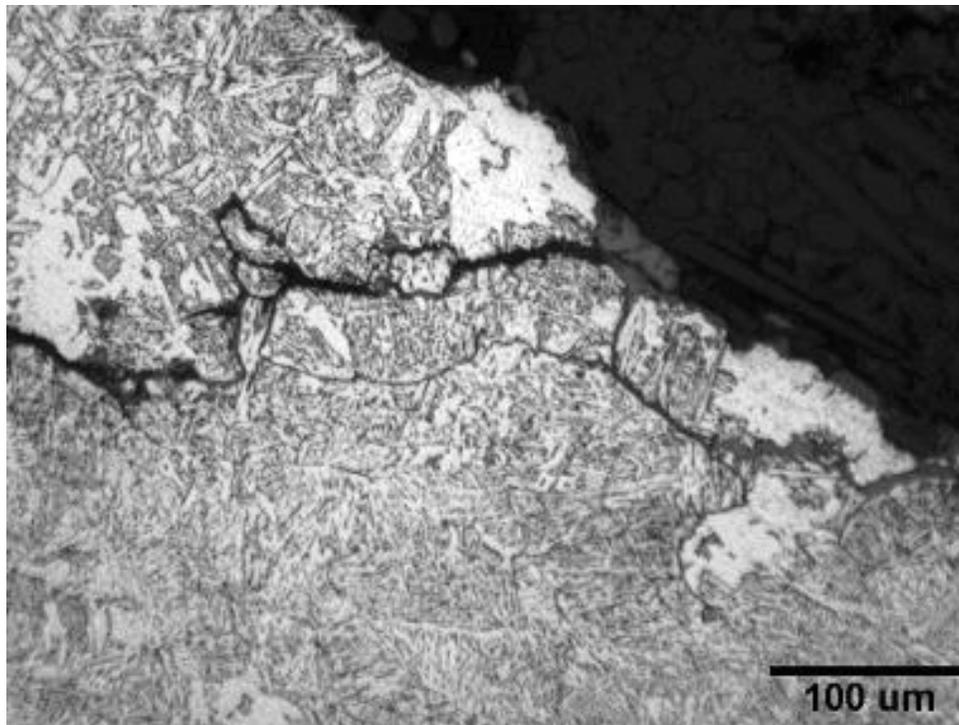
Figure 4-91 – Figure 4-90, etched.

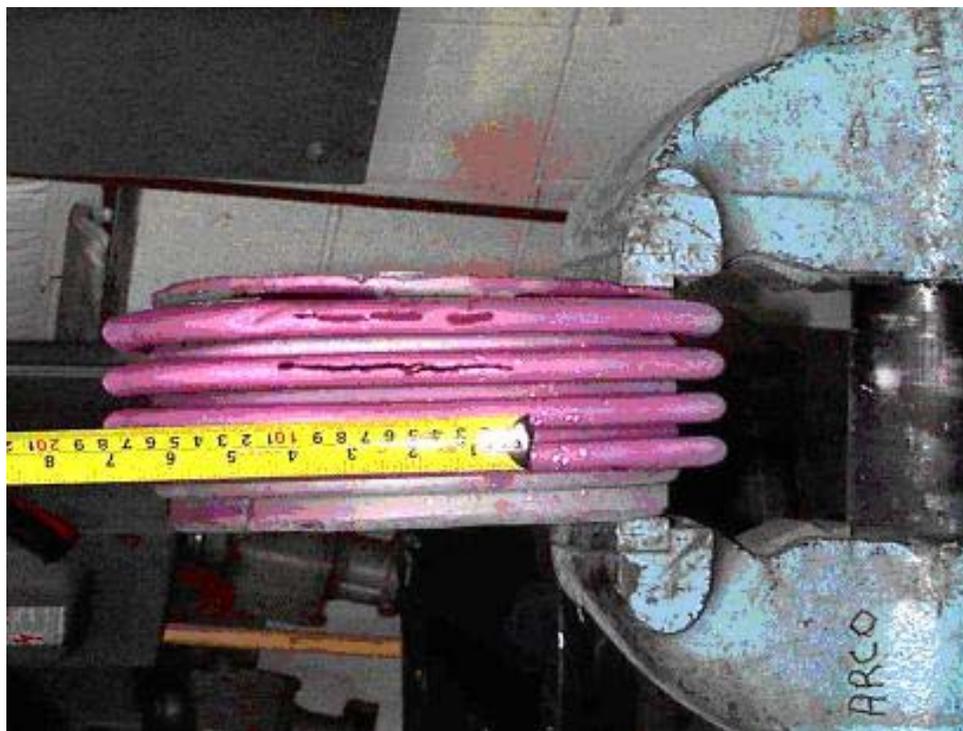
Figure 4-92 – Stainless steel expansion bellows from a steam-driven turbine previously subjected to a caustic carryover upset condition.

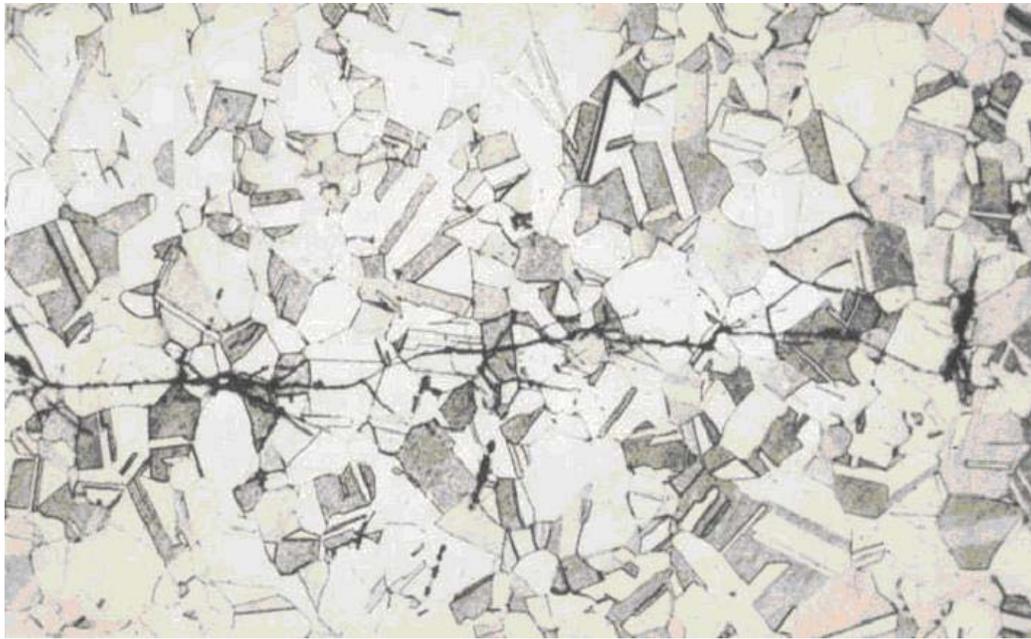
Figure 4-93 – High magnification view of a cross-section of a brass exchanger tube showing transgranular cracking.

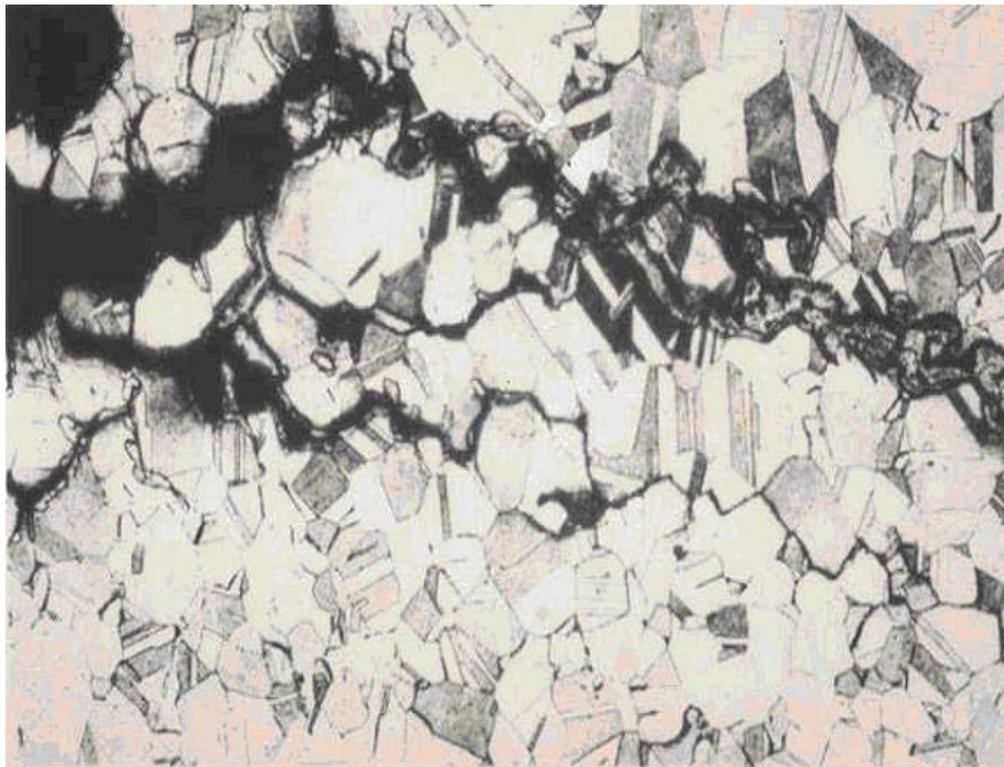
Figure 4-94 – High magnification view of a cross-section of a brass exchanger tube showing intergranular cracking.

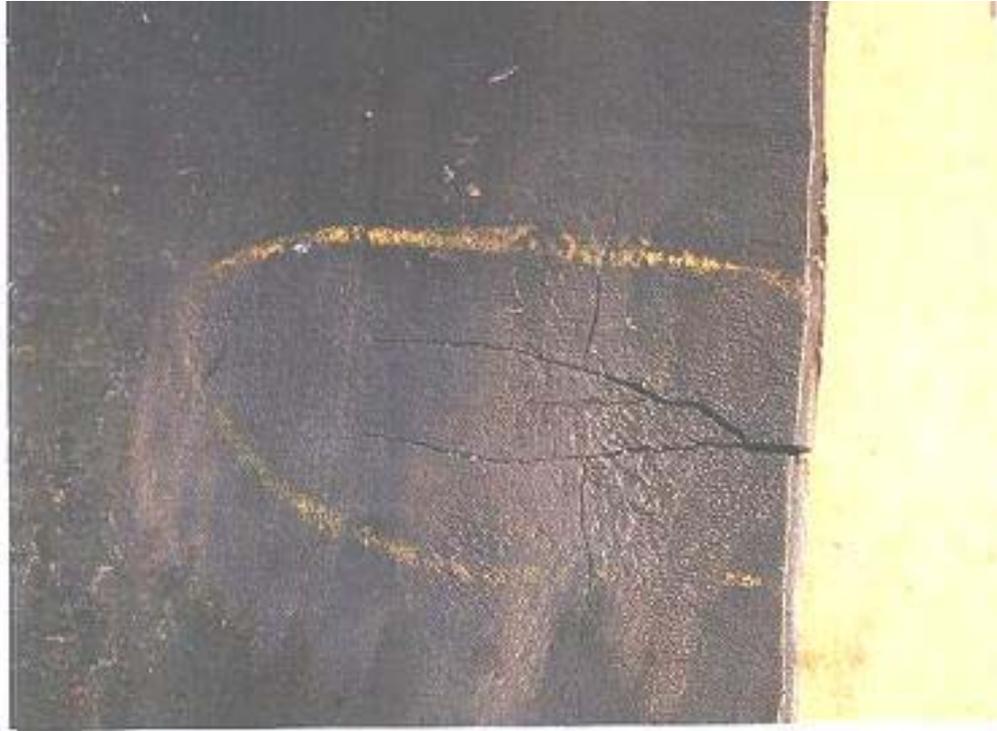
Figure 4-98 – Liquid metal embrittlement of Monel caused by mercury in an FCC gas plant overhead drum.

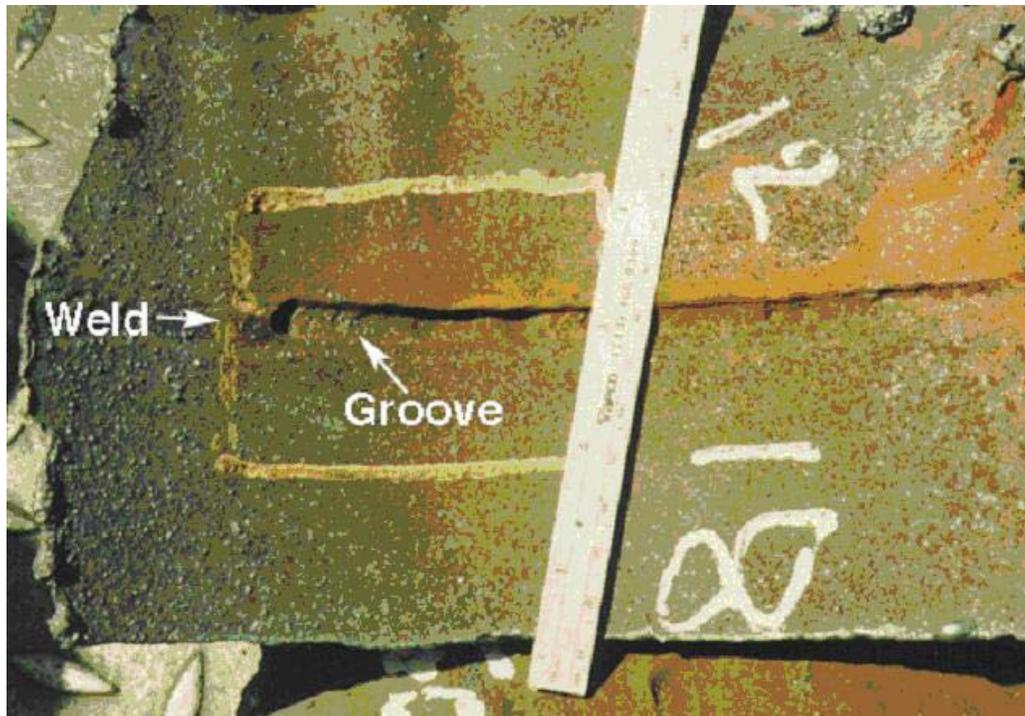
Figure 5.1 – Localized amine corrosion at the weld found in piping from reboiler to regenerator tower in an MEA unit. Many other similar cases found, some going as deep as half thickness. They were originally found and mistaken as cracks with shear wave UT inspection.

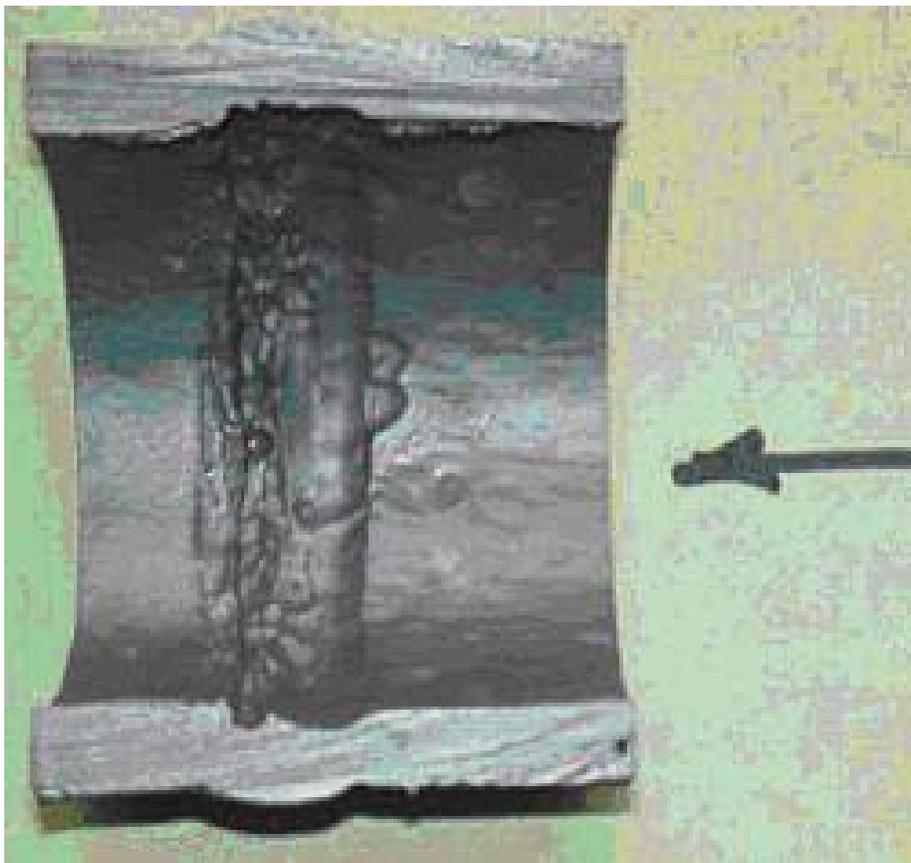
Figure 5-2 – 2-inch CS elbow and straight section in a sour water line off the cold HPS on an HDT unit.

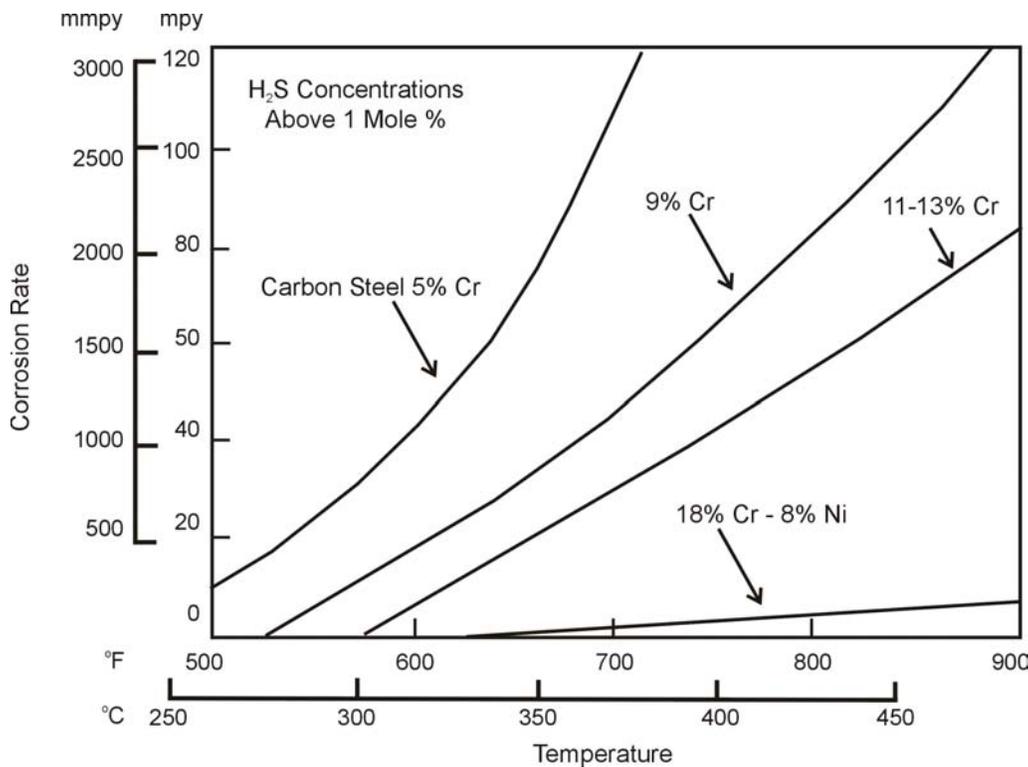
Figure 5-4 – Corrosion rate curves for various alloys in H₂/H₂S service. (Ref. 1)

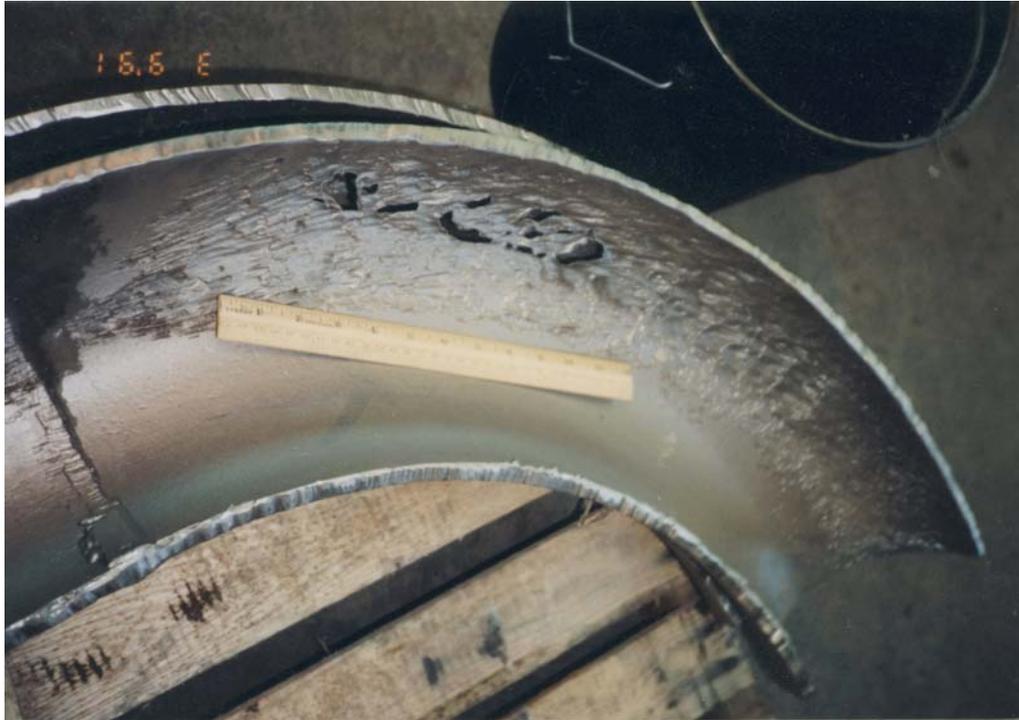
Figure 5-6 – Erosion-corrosion damage due to NAC in a 10-inch 5Cr elbow in the outlet of a vacuum heater in a VDU.

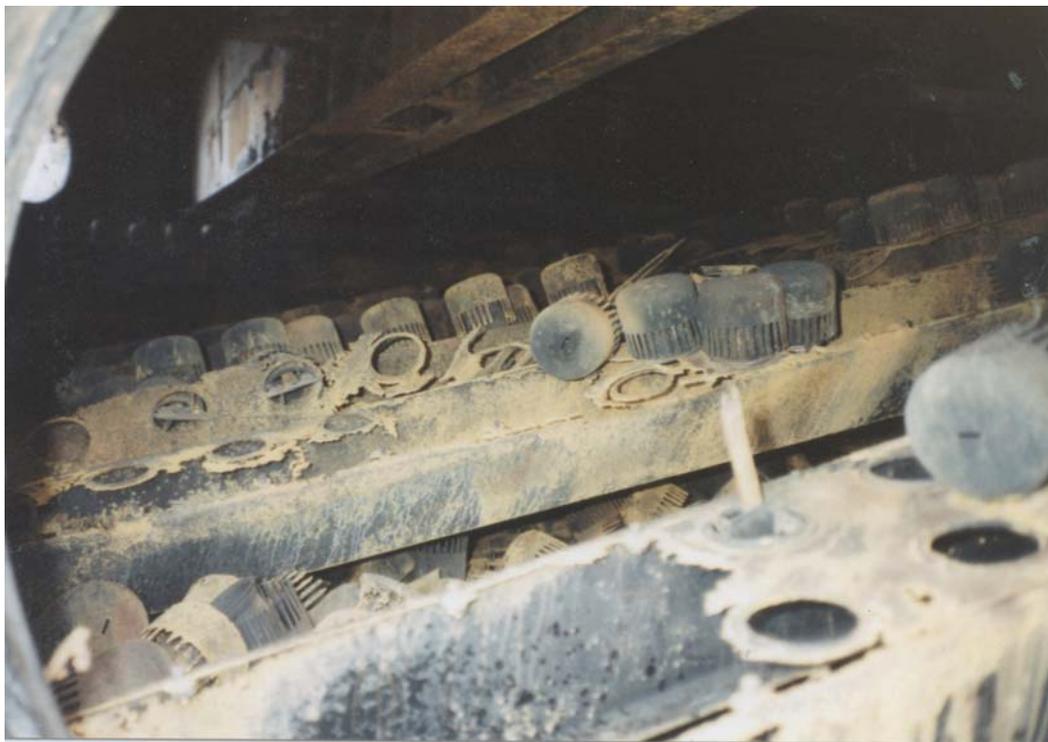
Figure 5-7 – Severe NAC of 410 SS trays and bubble caps in the HVGO section of the vacuum tower fed by the vacuum heater in Figure 5-6.

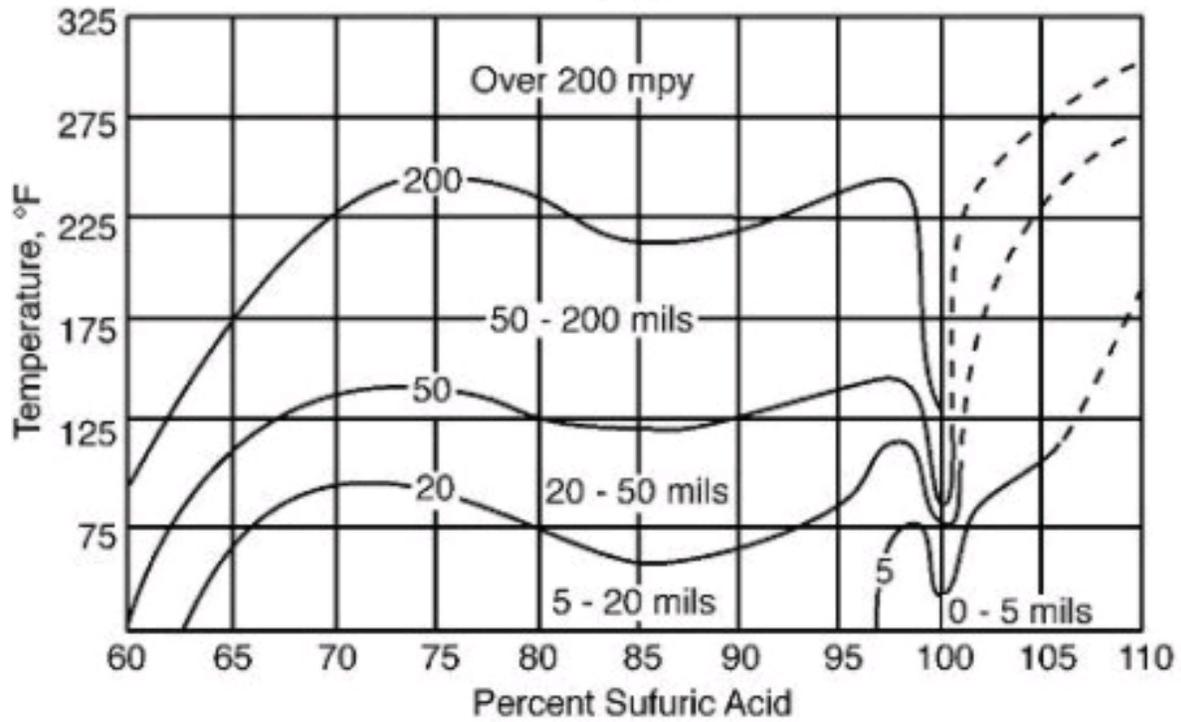
Figure 5-8 – Sulfuric acid corrosion data.

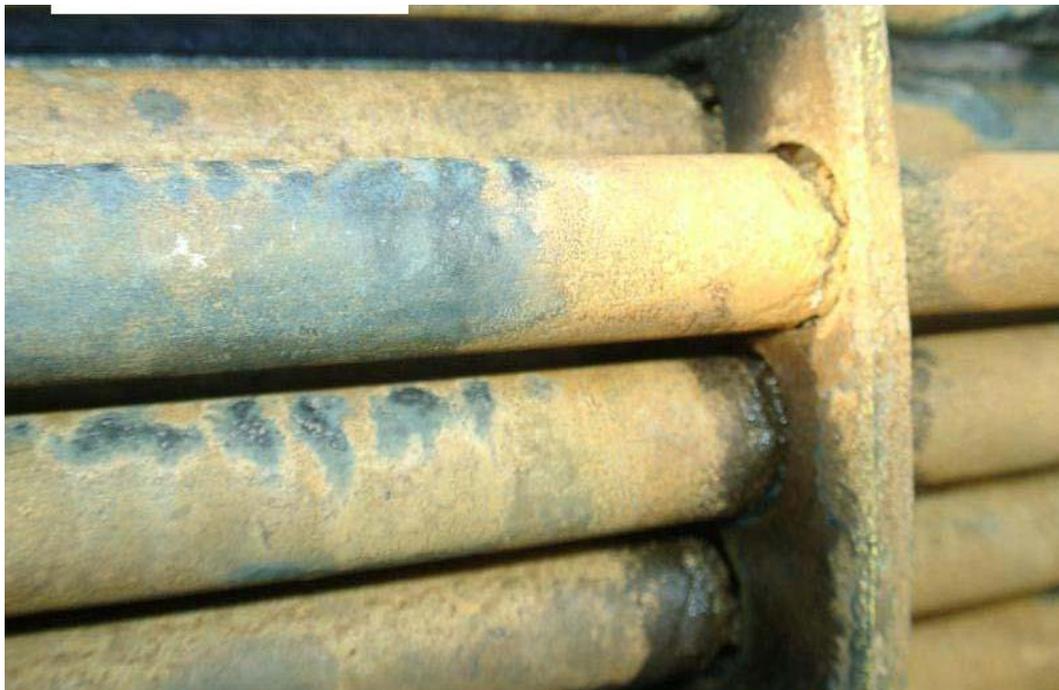
Figure 5-9 – Accelerated corrosion under a baffle.

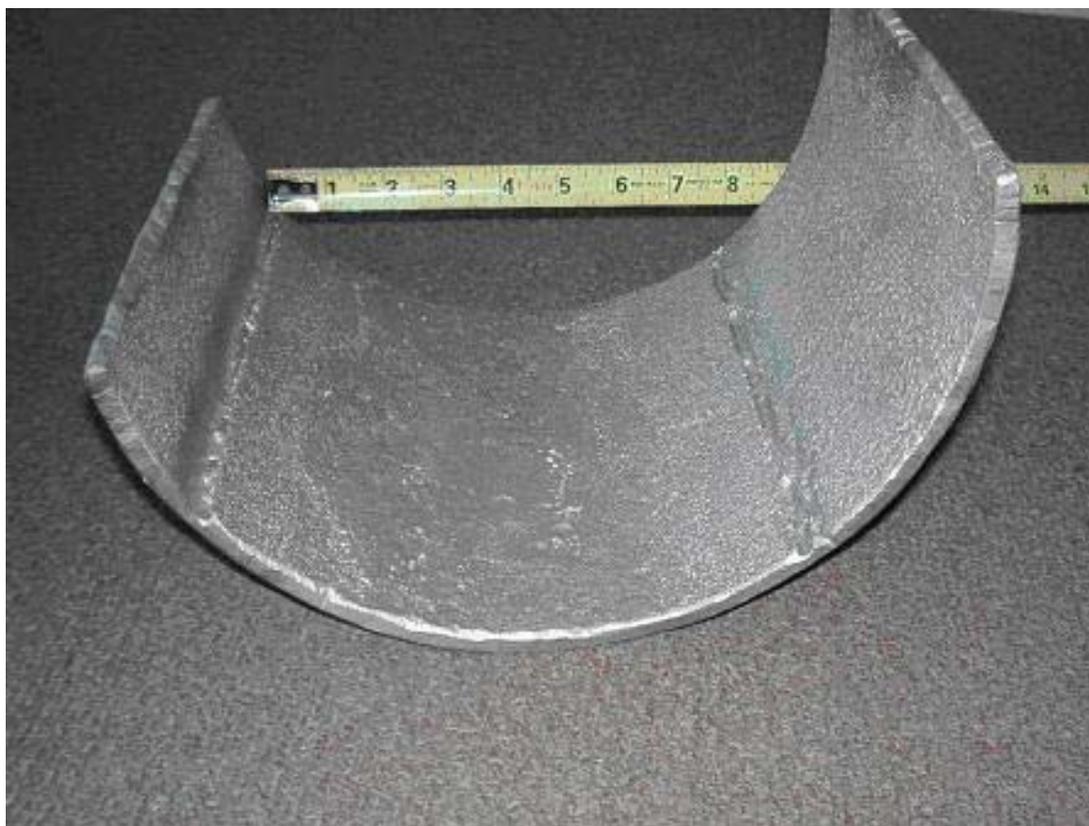
Figure 5-10 – Grooving corrosion in the carbon steel vapor line from an alkaline water wash drum in a sulfuric acid alkylation unit.

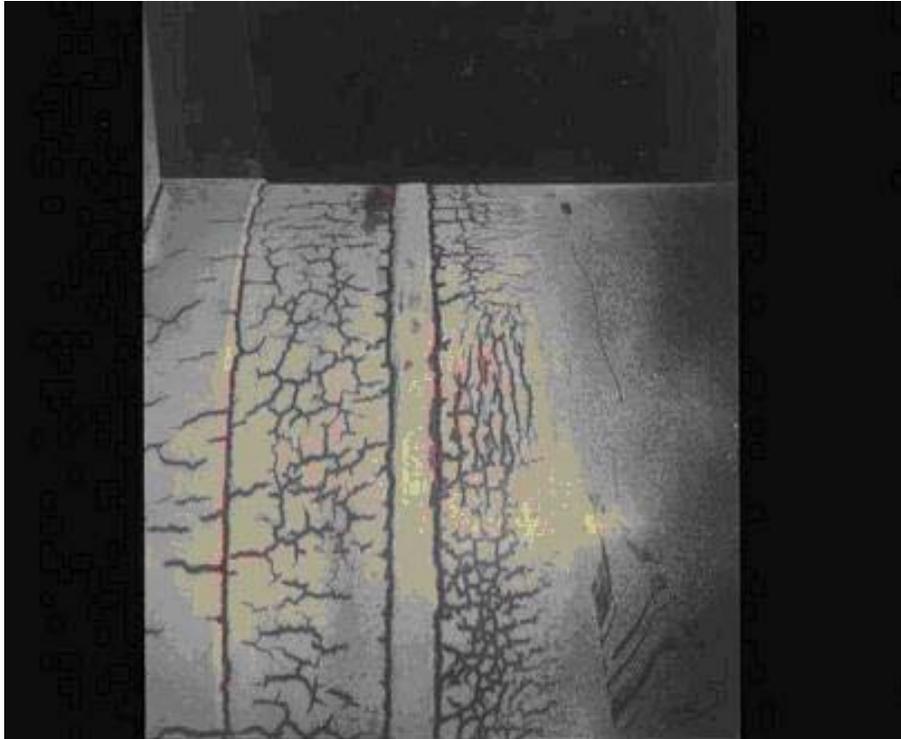
Figure 5-12 – Dye penetrant inspection showing extensive O.D. cracking around welds.

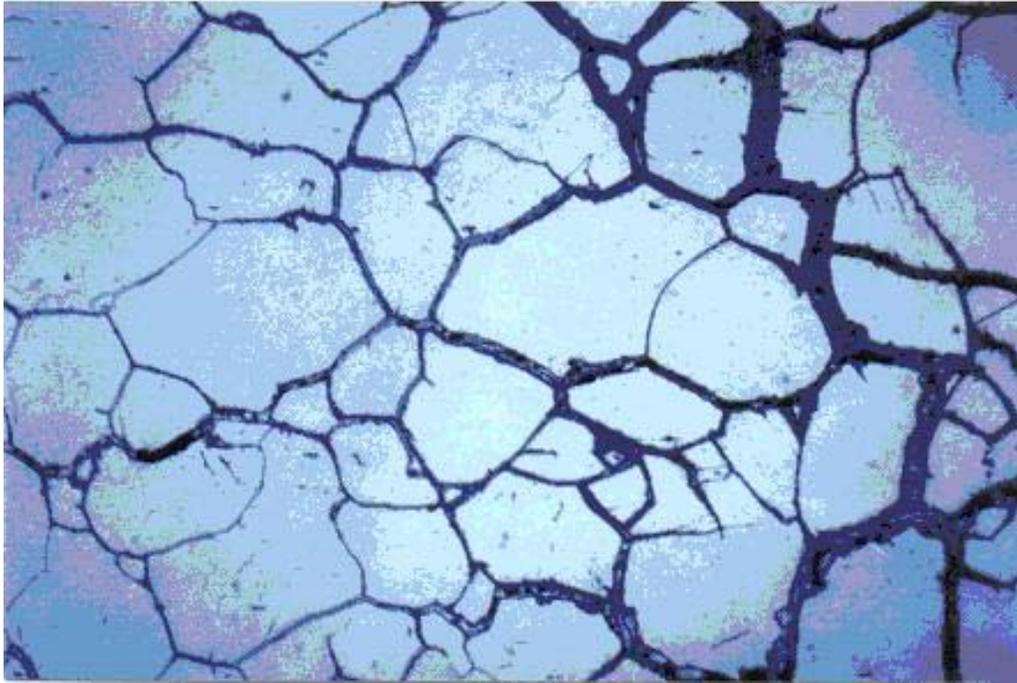
Figure 5-16 – Higher magnification view showing intergranular cracking. Mag. 200x

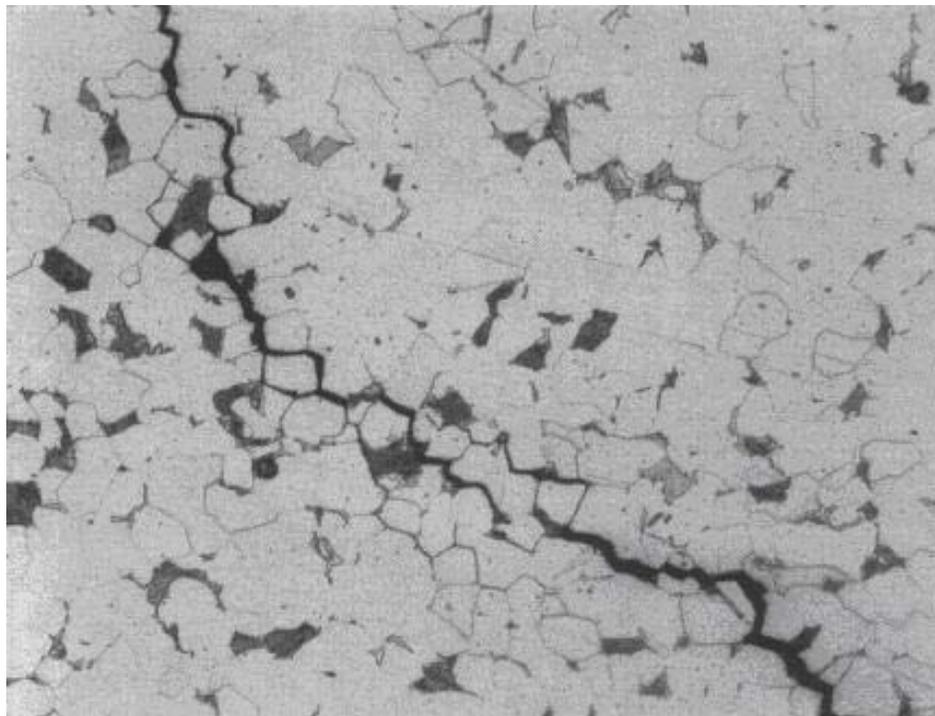
Figure 5-18 – A higher magnification view of the crack tip in Figure 5-17. Mag. 200x. (From API RP 945.)
