Damage Mechanisms Affecting Fixed Equipment in the Refining Industry

RECOMMENDED PRACTICE 571
FIRST EDITION, DECEMBER 2003

Downstream Segment

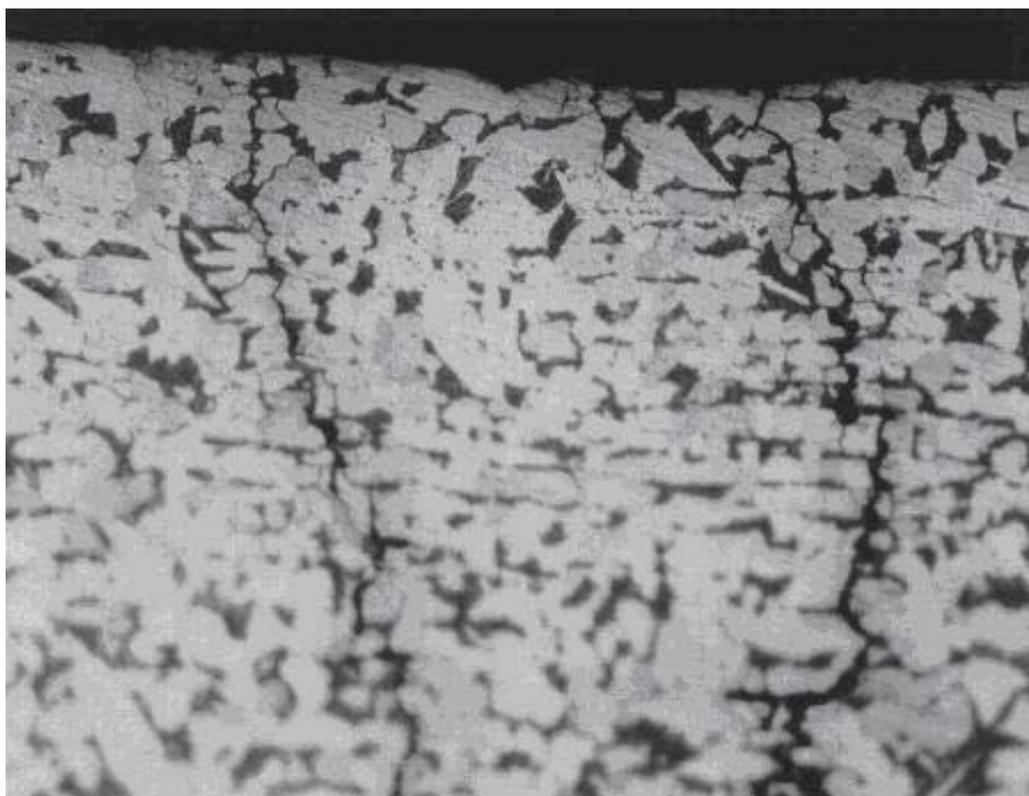
Figure 5-20 – A higher magnification view of the cracks in Figure 5-19 which illustrates the intergranular nature of cracking. Mag. 200x. (From API RP 945.)

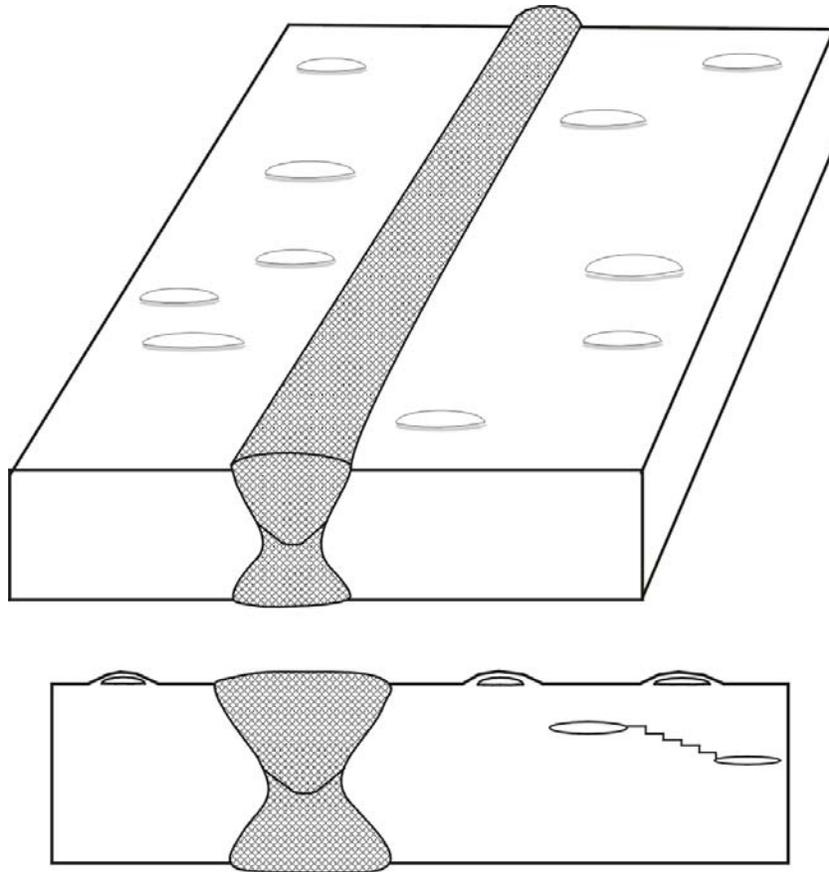
Figure 5-21 – Schematic of hydrogen blistering and HIC damage.

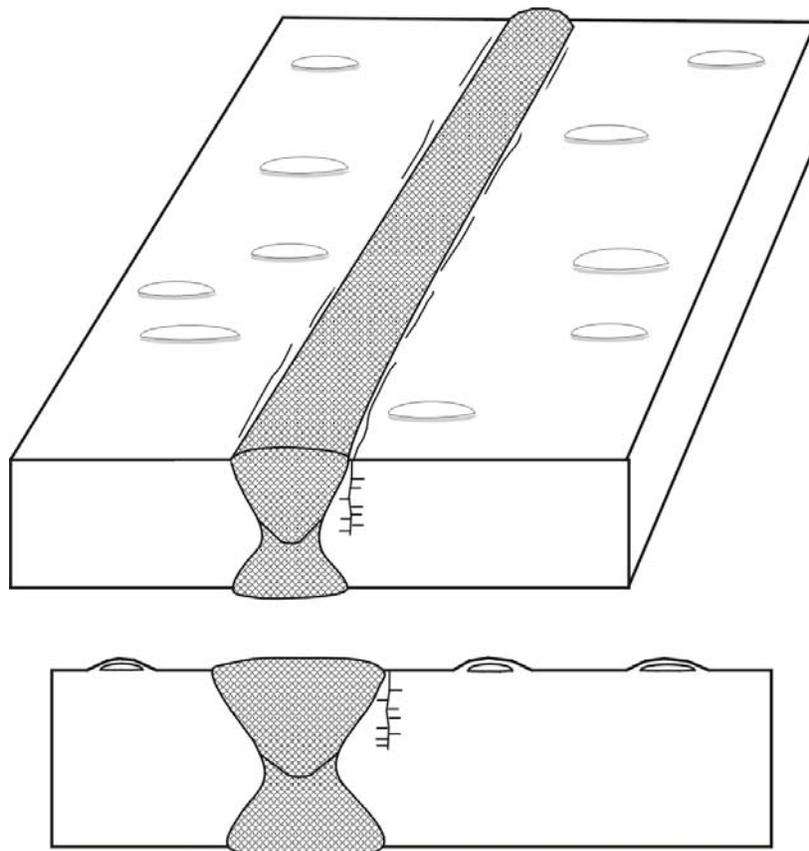
Figure 5-26 – Schematic showing hydrogen blistering that is accompanied by SOHIC damage at the weld.

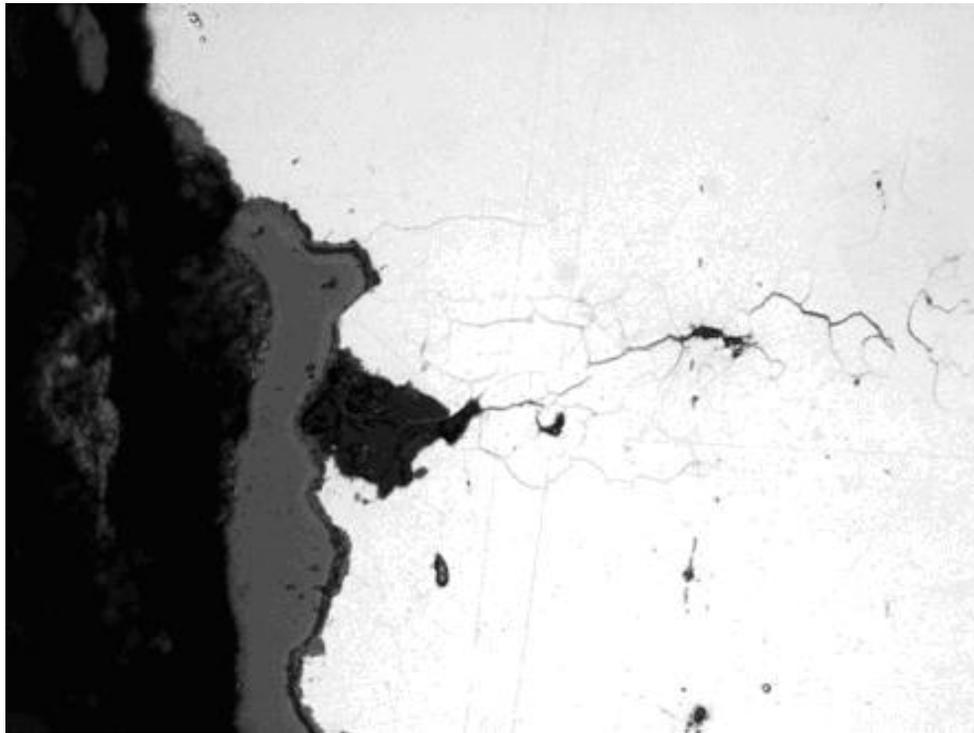
Figure 5-33 – Photomicrograph of a cross-section of carbonate cracking in the base metal, initiating at a corrosion pit on the ID surface. Unetched.

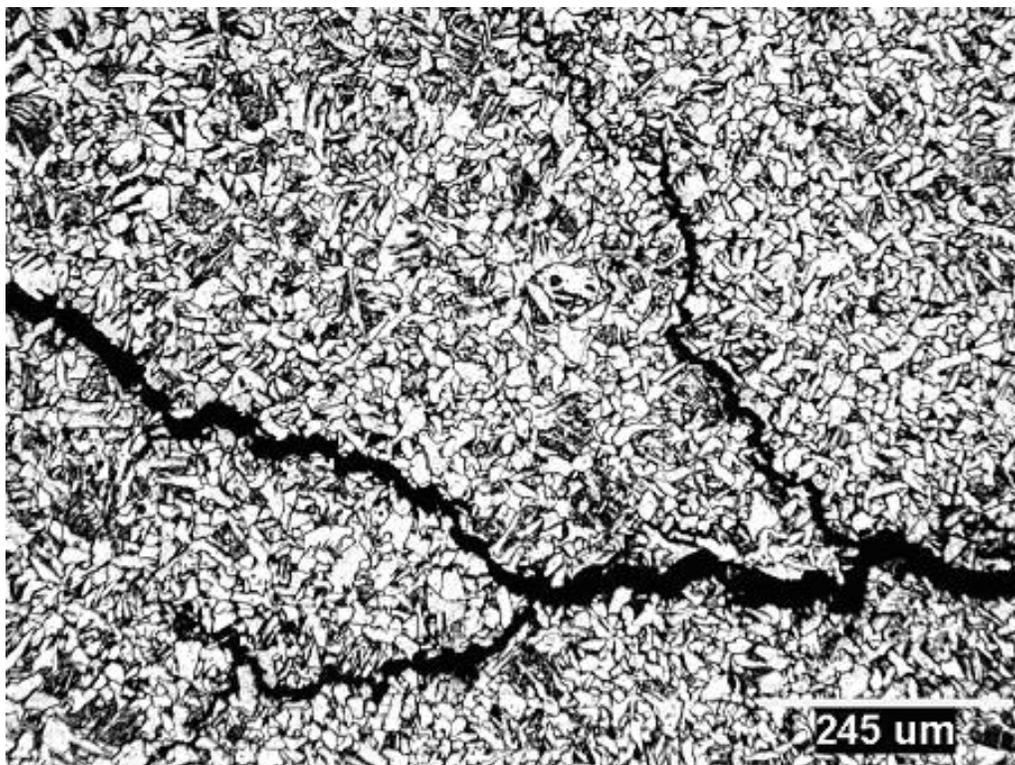
Figure 5-34 – Photomicrograph of a cross-section of carbonate cracking in the base metal, showing the branched nature of the cracking. Etched.

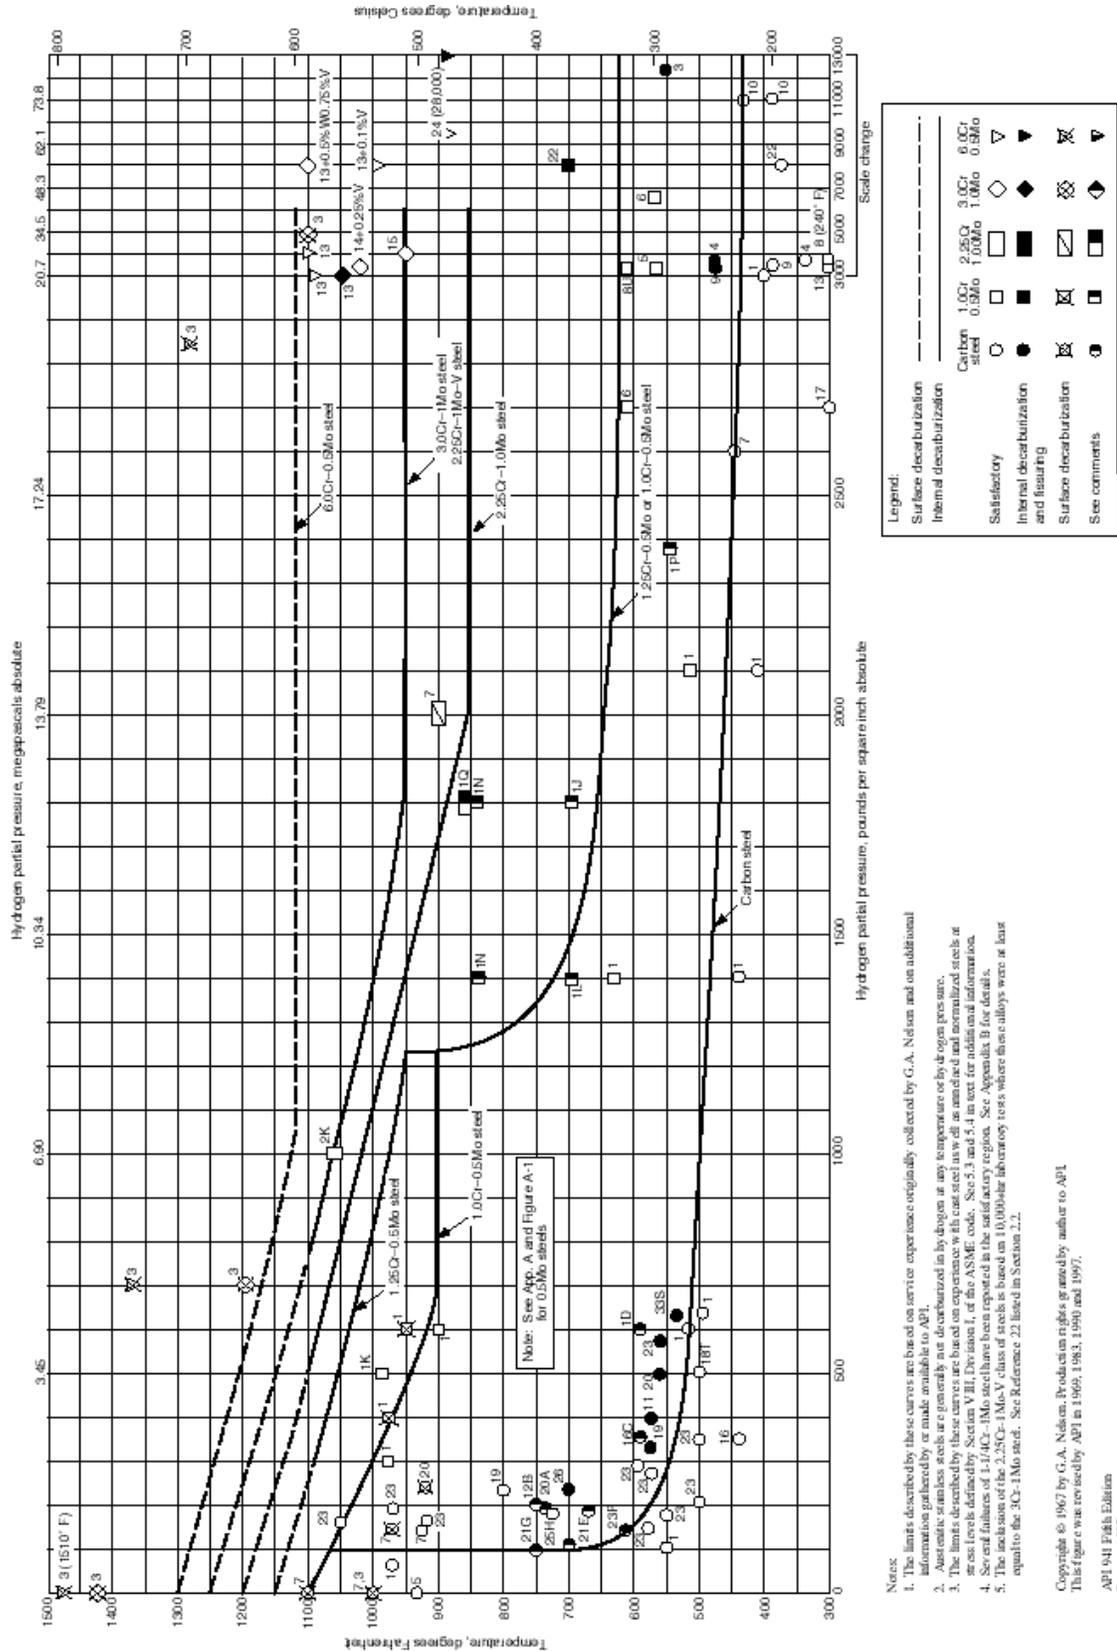
Figure 5-35 – Recommended pressure and H₂ partial pressure limits per API 941. (Ref. 1)

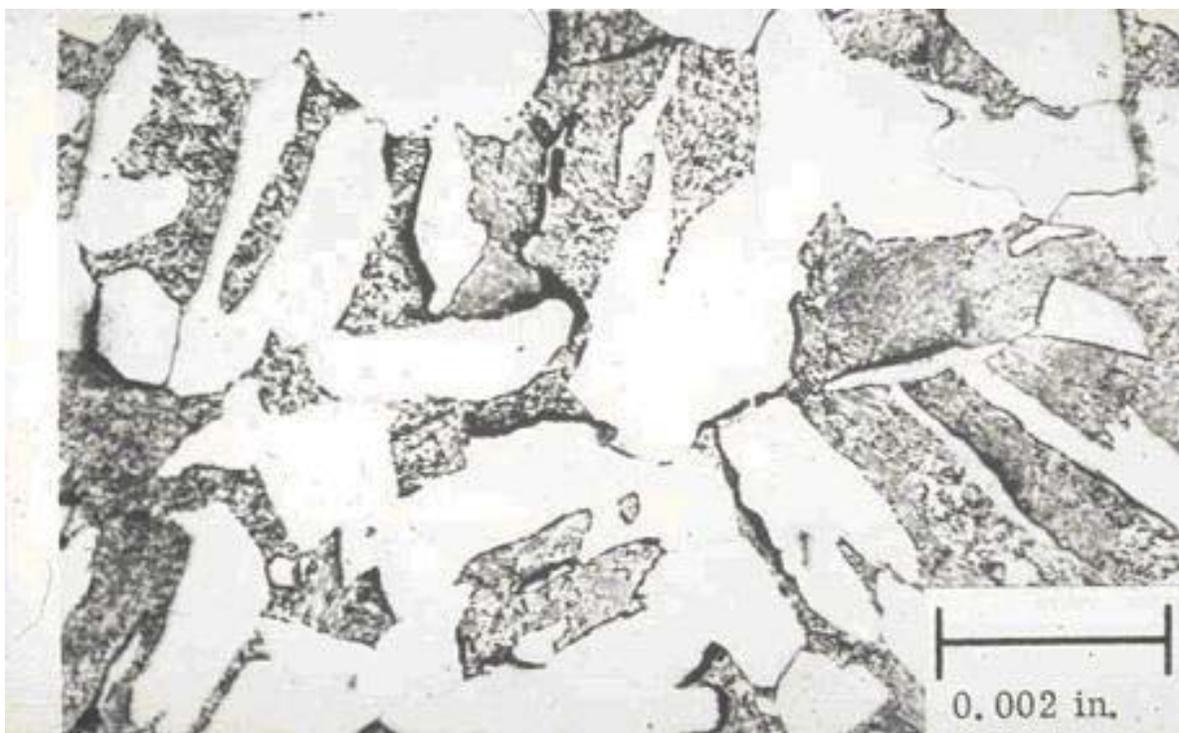
Figure 5-37 – High magnification photomicrograph showing microfissuring.

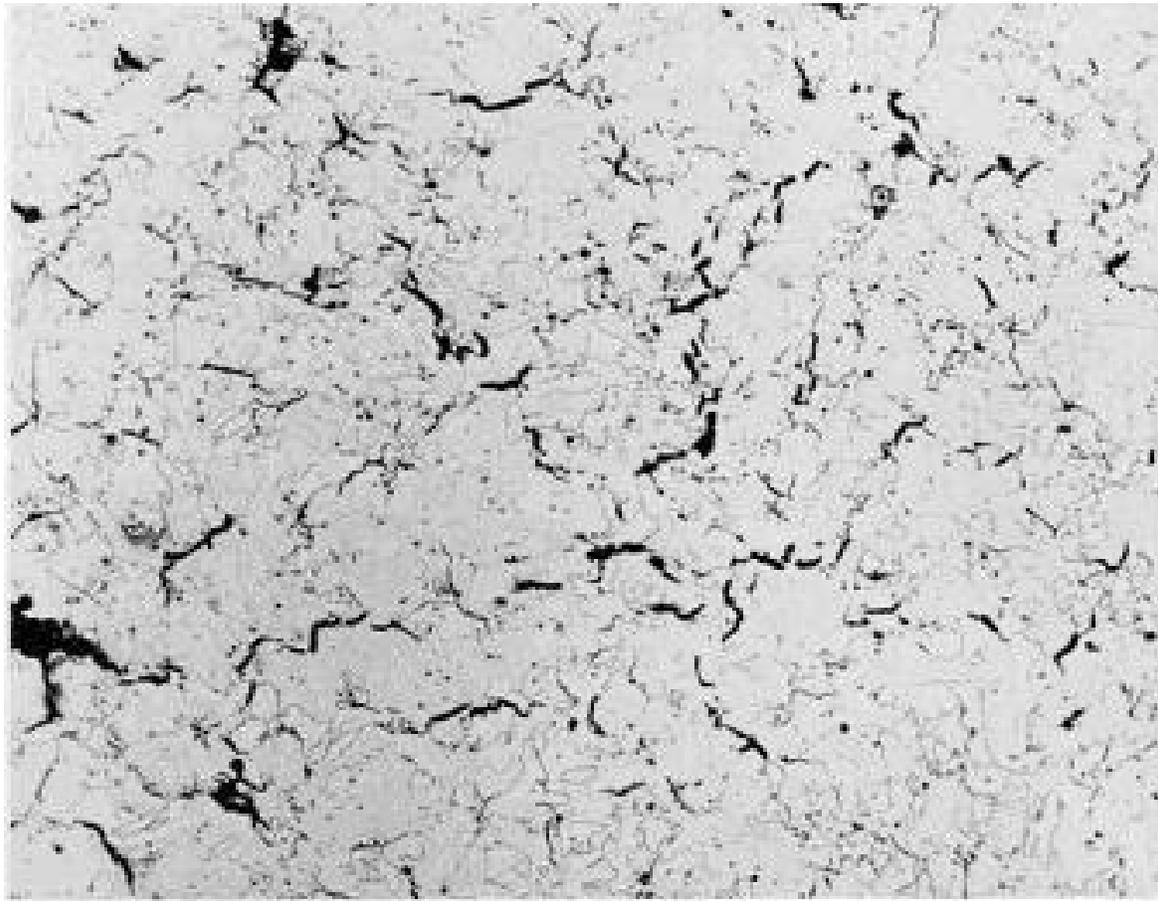
Figure 5-38 – High magnification photomicrograph showing linkup of microfissures to form continuous cracks. Note that damage is accompanied by a significant amount of decarburization.

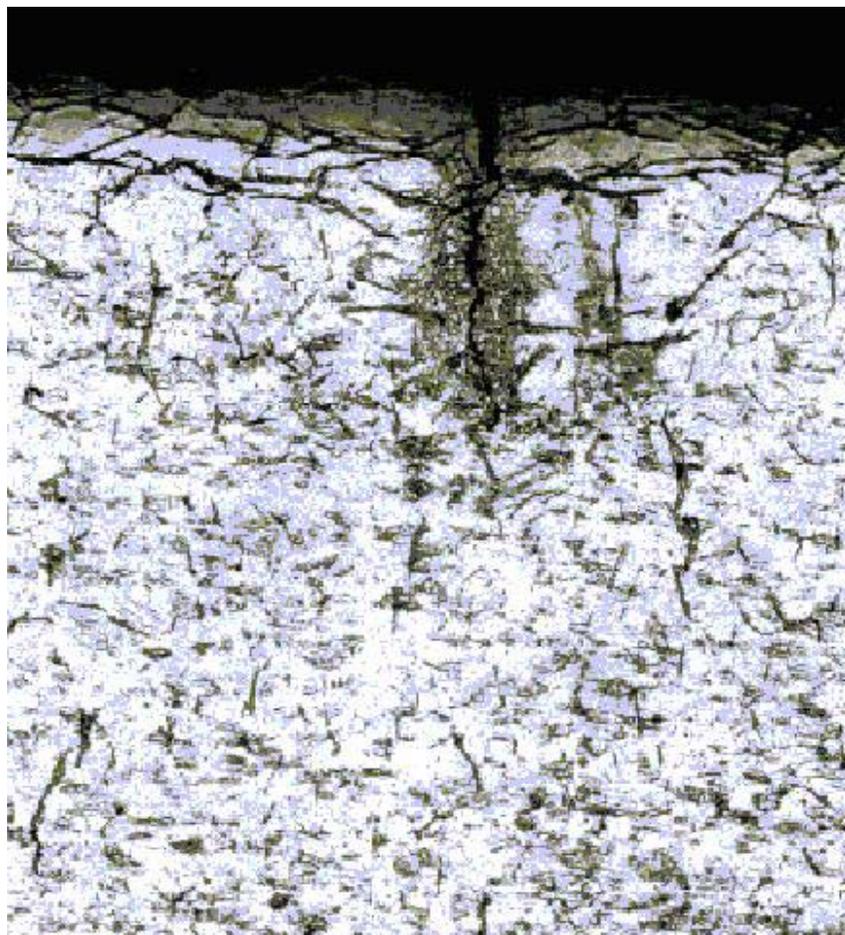
Figure 5-40 – High magnification photomicrograph of a cross-section of the tube shown in Figure 5-39 through the crack tip. Mag. 200x.

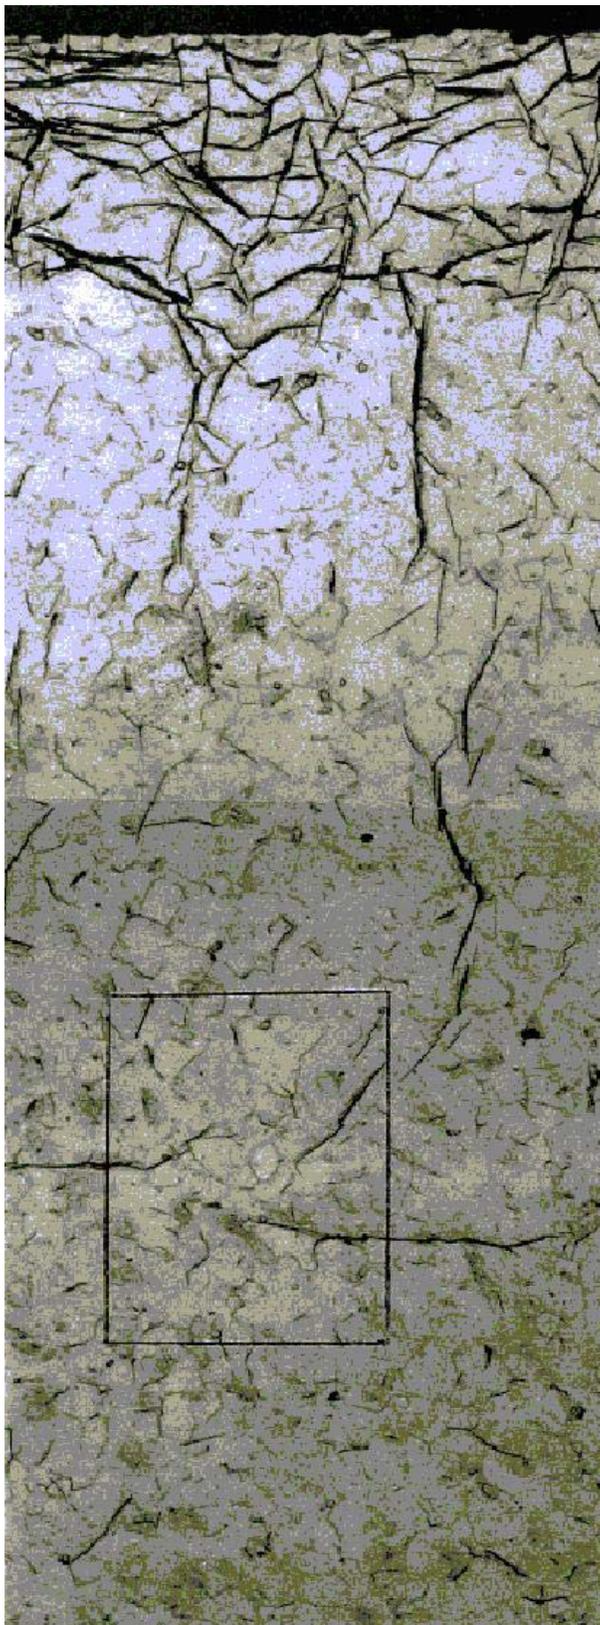
Figure 5-41 – Another high magnification photomicrograph of a cross-section of the tube showing more of the cross section through the tip of the crack. TI hydrides are more clearly discernable. Mag. 400x.
